ANALYSIS OF GAS COMPRESSOR UNIT ACCIDENT FACTORS

O.L. Bulgakova

Scientific advisors associate professor N.V. Chukhareva, associate professor I.A. Matveenko
National Research Tomsk Polytechnic University, Tomsk, Russia

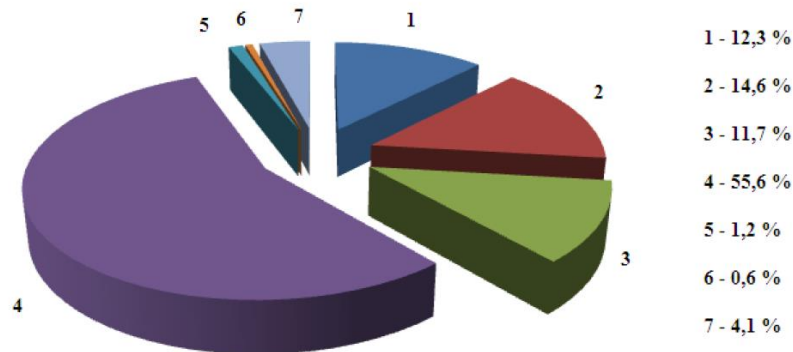
According to the statistic data, each category of reasons was described by weighting factor (in percentage) in order to determine its contribution to the overall statistics (Fig.).

Fig. Accidental situation of electrical motor-driven compressor unit within period 2005 - 2012 in dependence of their causes: 1-failure/malfunction of electrical equipment; 2 – failure of instrumentation and control equipment systems; 3 – mechanical damage; 4 – power supply problems; 5 – administration system problems; 6 – oil system problems; 7 – operational imperfection

Based on the obtained results, failure history of electric motor-driven compressor unit, basic accident causes were:

- failure of electrical equipment;
- failure of instrumentation and control equipment systems;
- mechanical damage;
- power supply problems.

Above-mentioned main accident causes are largely determined by the influence of the human factor which determines the effective and safe operation of compressor unit not less than the technique. All this causes are qualified as regulated and controlled parameters by improving professional skills of service personnel and implementing technical standards.
