# Ultrasonic Phase Array and Eddy Current Methods for Diagnostics of Flaws in Friction Stir Welds

**Abstract.** The feasibility of the defect detection in friction stir welds of aluminum alloys with the use of two different non-destructive testing (NDT) methods has been studied. We have used the following NDT techniques: ultrasonic phase array and eddy current methods. A metallographic examination was chosen as the third method. The weld flaws such as kissing bond boundaries, lack of penetration, voids and cracks have been successfully detected using the ultrasonic phase array technique. The eddy current method enabled the detection of a weld root flaw.

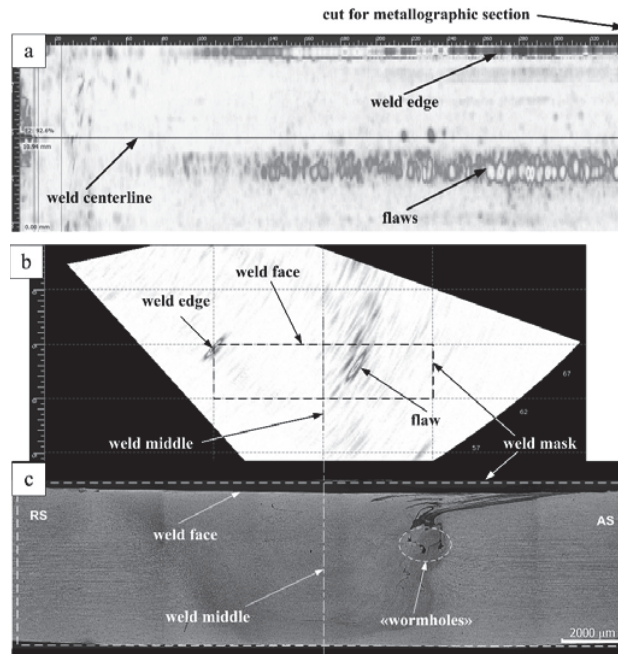
**FIGURE 1.** “Wormhole” weld defects: (a) US “top-view”, (b) US S-scan, and (c) metallographic section

The US image of defects shown in Fig. 1 can be considered as a transparent plain view of the entire sample where all the defects can be seen independently of their depth below the surface. One can see that all defects have the form of chain-like band at the same depth and at the distance of 2–3 mm from the weld centerline closer to its advancing side (AS).

For identifying the defects, we prepared the cross section polished view of this weld in the plane as shown by the dashed line in Fig. 1(a). Comparing the US-scan image of the defect in Fig. 1(b) and the optical cross section image in Fig. 1(c) one can see that the location of the US-scan defect zone in Fig. 1(b) coincides with that of voids in the optical cross section view (Fig. 1(c)).

The almost equiaxed voids are located in the AS at depth from 1 to 2.5 mm below the weld surface and can be denoted as “wormhole” defects according to the common classification. The size of this zone may vary, but its right boundary will be always at the interface of the weld and base metal. Generation of that type of defect is related to the specificity of friction-plasticized and modified metal flow in the vicinity of a stationary base metal [4].

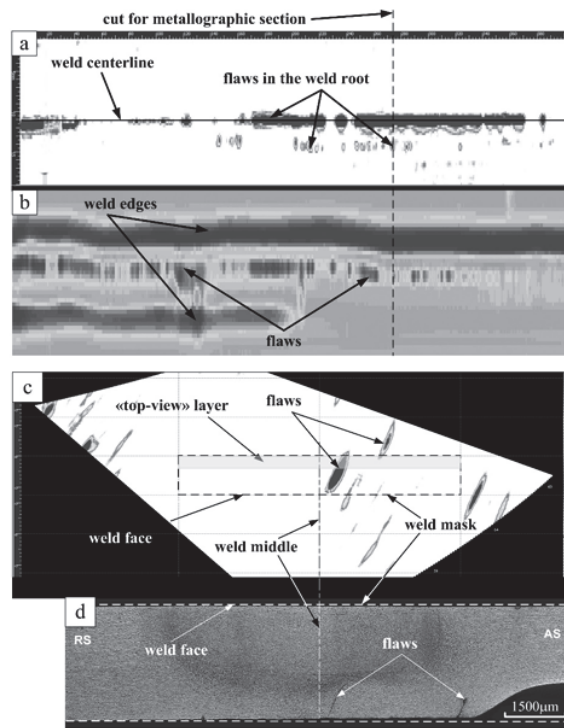
For some segments more defects were found by the US technique, while some of them were found by the eddy current method. The eddy current testing was unable to detect a chain-like defect 2–3 mm away from the weld centerline, which was clearly visible in the US-image (Fig. 3(a)). The cross section plane for metallography was chosen to enable visualization of both the root flaw and one of the chain-like defects parallel to the weld centerline.

The defect location in the US S-scan (Fig. 3(c)) coincides again with that of the real defects shown in the cross section view (Fig. 3(d)). The defect in Fig. 3c located closely to the weld centerline is a reflection from a crack developed along the “Lazy S” line. Another defect corresponds to the shorter crack located on the advancing side.

It should be noted that the aluminum alloy sheet edges were not mechanically processed to remove the oxides and, therefore, the Lazy S defects were present in all samples; however, they were detected only when a crack propagated along it.

**FIGURE 3.** Lack of penetration internal weld defects: (a) US “top-view”, (b) eddy current scan, (c) US S-scan, and (d) metallographic section
