Thermography Inspection of Friction Stir Welding

Abstract. The feasibility of thermography for detecting weld defects directly in the process of friction stir welding (FSW) is evaluated. Several types of temperature anomalies are revealed for friction stir welds, which are related to real seam defects, such as lack of penetration and wormholes found from the following metallographic examination.

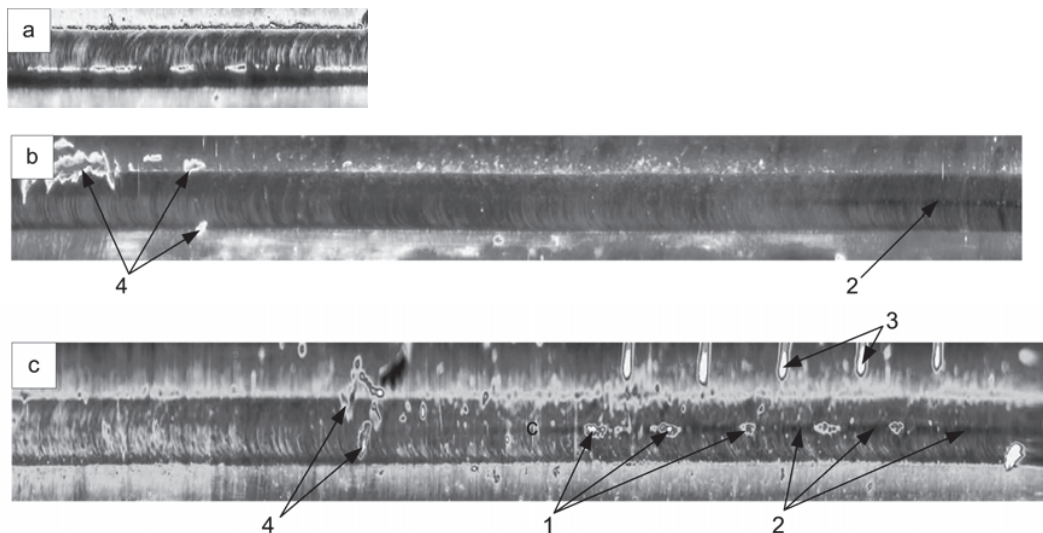
FIGURE 2. Thermogram fragments of welds produced in different welding modes

Several types of anomalies can be distinguished from the thermograms. The first type is a narrow, white or light gray, continuous, discontinuous or segmented line in the middle of the weld (designated by 1 in Fig. 2(a)). The second type is a narrow, darker than the surrounding area, line in the middle of the weld (designated by 2 in Fig. 2(b)). As a rule, this line was only observed on a part of the weld. It is clearly seen in the right part of the image in Fig. 2(b). Visual inspection revealed no anomalies on the weld face corresponding to that dark line region.

Figure 2(c) demonstrates the workpiece having both of the above-described anomalies, also designated by 1 and 2. The given workpiece had artificial defects introduced prior to welding, namely, a series of five Ø5 mm diameter 2.5 mm depth holes drilled along the in the centerline of the butt joint. The lines drawn by the marker (designated by 3) are clearly seen on the thermogram and designate the positions of these holes before welding. There are also five lack-of-penetration defects formed behind the holes after the passage of the tool (Fig. 2(c)). Their location corresponds exactly to the location of the lack-of-penetration defects detected by visual inspection. Between these defects, there is a well-defined darker line distinct from the surrounding area (Fig. 2(c)).

Other anomalies found are the large bright regions at the weld ends and on the weld (designated by 4 in Fig. 2(b, c)). Flash is detected in these regions by visual inspection after welding. Also the heating can be inhomogeneous along the weld, namely, temperatures in the left, central and right weld parts may be slightly different. These anomalies are probably related more to the welding rather than to the formation of defects.

The literature reports on a very modest progress in detection and identification of weld defects by passive thermography, which mainly consists in the detection of surface defects such as lack of fusion or penetration [4]. An example of the defect is the lack of penetration detected in the present paper (bright line in Fig. 2(a)). The presence of such defects can be easily observed visually.

Another type of defect is the lack of penetration beneath the weld face (Fig. 2(c)), which is evidently formed due to the bad compatibility between the plate edges. The hidden lack of penetration (Fig. 2(c)) is observed on the thermogram as the dark line with decreased temperature relative to defect-free regions between the bright spots of artificially introduced defects.

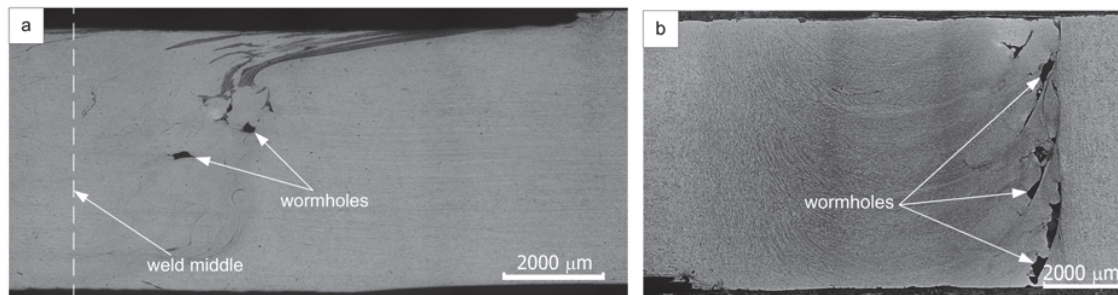
The metallographic analysis of the weld cross-section in the dark line region (right part of the workpiece in Fig. 2(b)) has revealed the presence of wormhole defects 2–3 mm below the surface (Fig. 3(a)). The distribution of defects by depth has been obtained from a layer-by-layer metallographic analysis of in-plane weld sections. The macrograph of a section at 2.4 mm below the weld surface is given in Fig. 3(b) where defects formed by the rotating FSW tool are seen. The formation of wormhole defects can be considered from the viewpoint of papers [6] showing that the flow of the material in the friction zone can be accompanied by turbulence and formation of discontinuities.

FIGURE 3. The cross-section (a) and in-plane section (b) in the dark line zone shown in Fig. 3(b)

According to the thermography theory [5], the wormhole defects (Fig. 3) during cooling must appear as dark regions. The temperature anomaly represented by the dark line in Fig. 2(b) is located exactly along the weld centerline, while real defects of this type are found closer to the advancing side of the weld (Fig. 3). There is a discrepancy between the location of real defects and defects detected by infrared inspection across the weld width. However, other defects are also absent in the dark line region, e.g., lack of penetration beneath the weld face (Fig. 4) which could be related to the presence of the dark line.

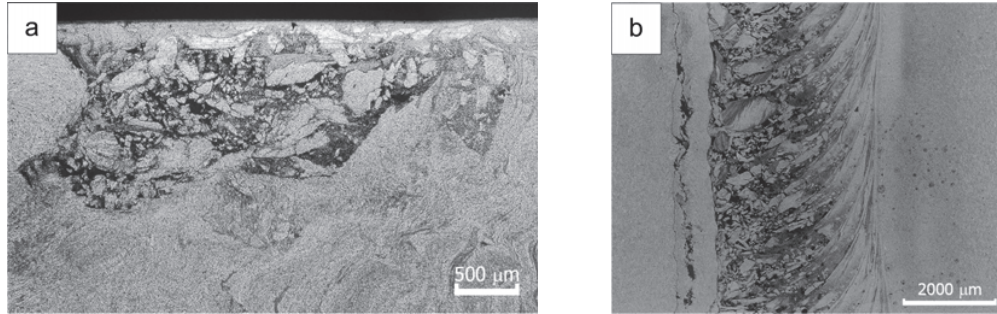
Another workpiece whose thermogram shows up the dark line temperature anomaly represented (Fig. 2(c)) has a defect illustrated in Fig. 4. This defect is a group of discontinuities of various shape and size, which is asymmetric relative to the weld centerline (Fig. 4(a)). The defect is extended (Fig. 4(b)) and is located directly beneath the weld face at a depth of up to 1.5 mm. In fact, the described defect is the lack of penetration smeared by the welding tool shoulder. This is also confirmed by its structure resembling the loose rock structure, which is found inside of visually observed lack-of-penetration defects. Despite the fact that the defect is located very close to the weld face (its minimum depth of occurrence is approximately 100 µm), it cannot be detected by visual inspection.

The structure of the defect is seen on a metallographic section parallel to the workpiece surface at a 1 mm depth; this structure is a group of circular segments with a spacing coinciding with the weld ripple spacing. The given defect is very dangerous as it greatly reduces the effective cross-section area of the material in the weld joint, which sustains the applied loads.

FIGURE 4. Defect represented by an extended zone of loose material corresponding to the dark line in Fig. 3(c): weld cross-section (a) and in-plane section at a 1 mm depth (b)
