Visual inspection results and evaluation of Akhtala tailing safety based on tailing management facility safety methodology

K. Sahakyan✉, A. Sarukhanyan

National University of Architecture and Construction of Armenia, Yerevan, Armenia

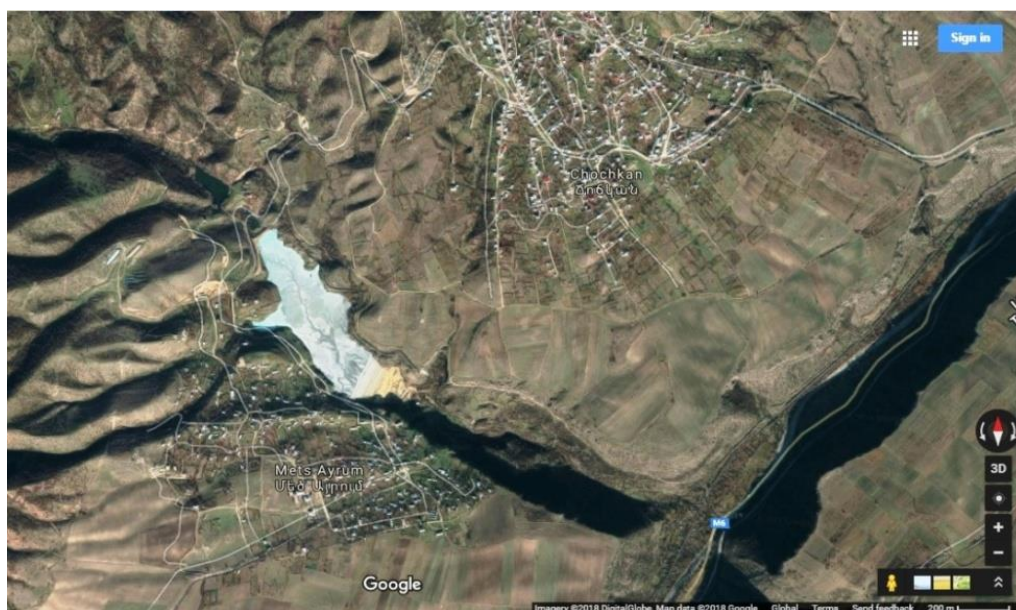
Fig. 1. Location/view of the Nahatak TMF of the Akhtala ore dressing combine

A visual inspection showed that the tailing dump was more than 80% full, and the surface of the lake was approximately 8 ha.

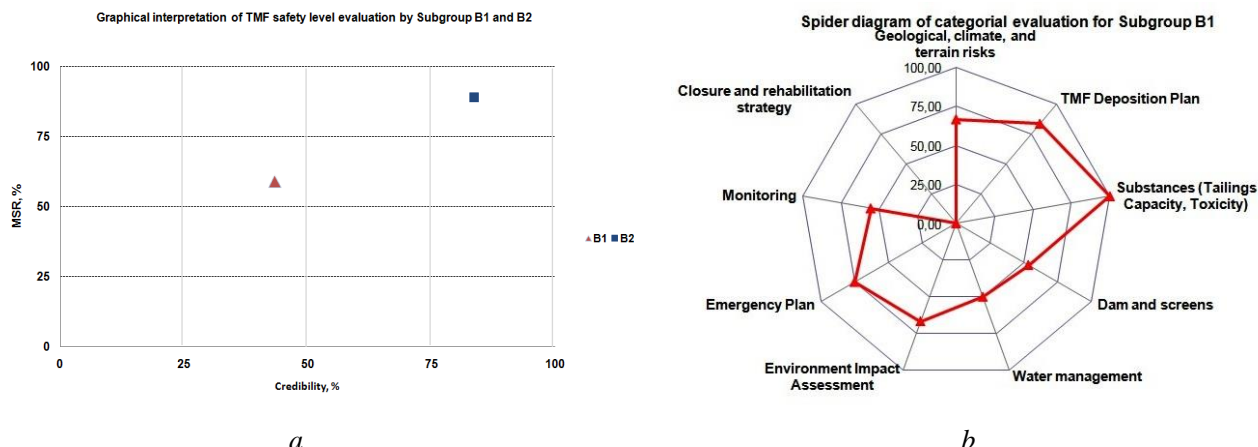
Fig. 2. Safety evaluation results for the main dam: a) overall evaluation; b) categorial evaluation for visual check

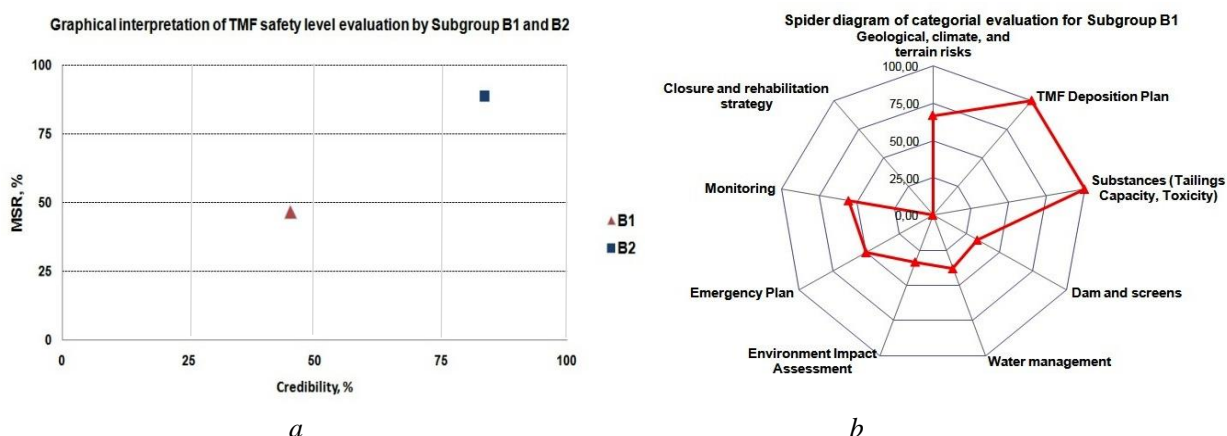
Fig. 1. Safety evaluation results for the drainage canal: a) overall evaluation; b) categorial evaluation for visual check

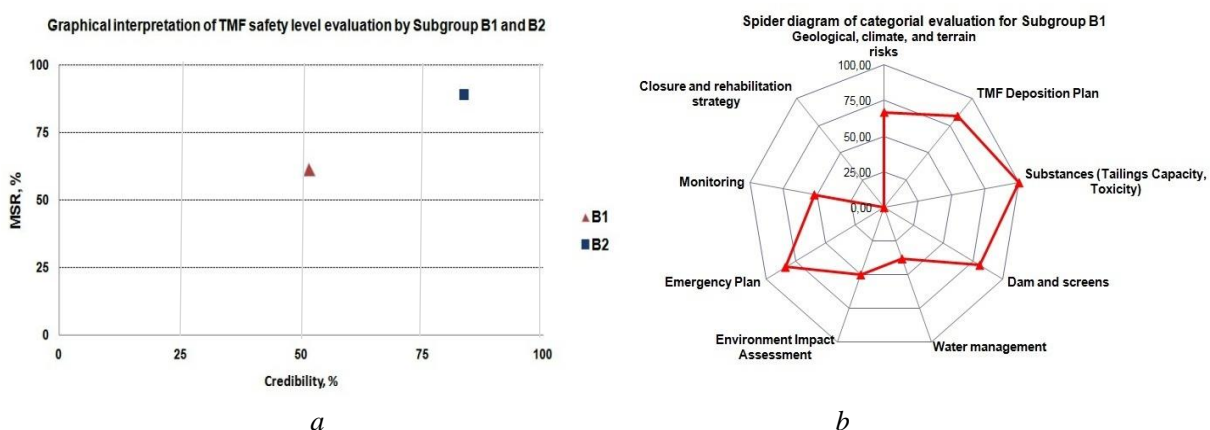
Fig. 2. Safety evaluation results for the secondary dam: a) overall evaluation; b) categorial evaluation for visual check

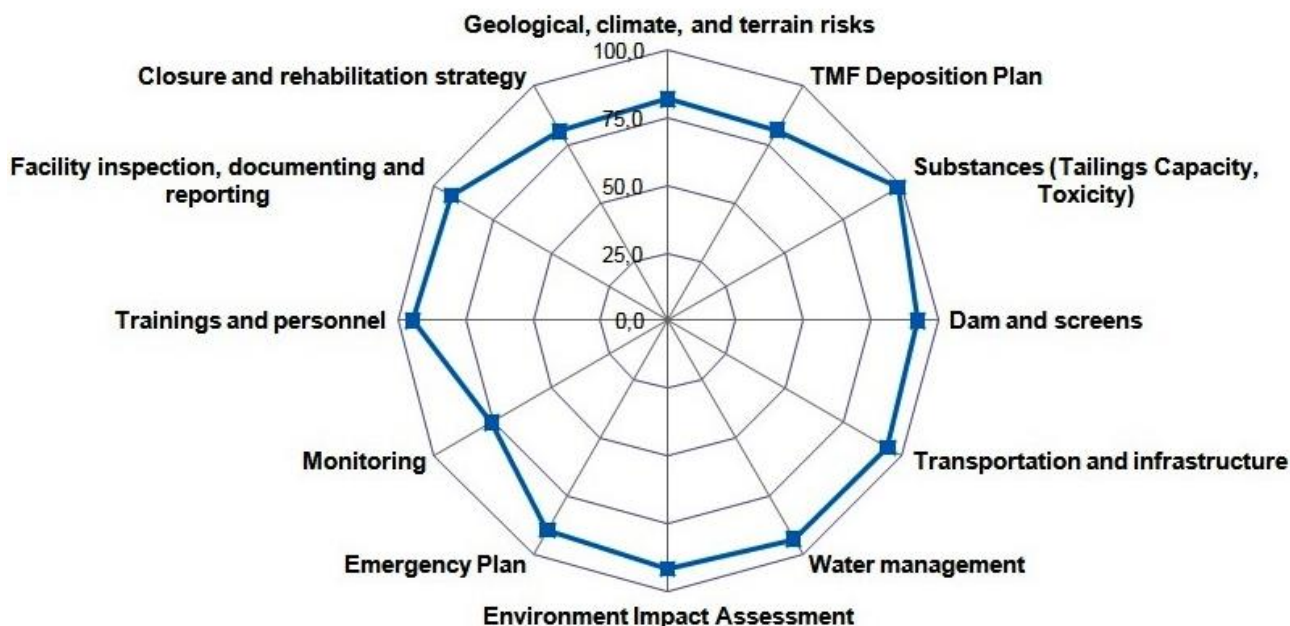
Fig. 5. Safety evaluation results obtained by document check
