Article

Application of the Electrochemical Permeation Method for Hydrogen Diffusion Coefficient Determination in Pipeline Steel 10G2

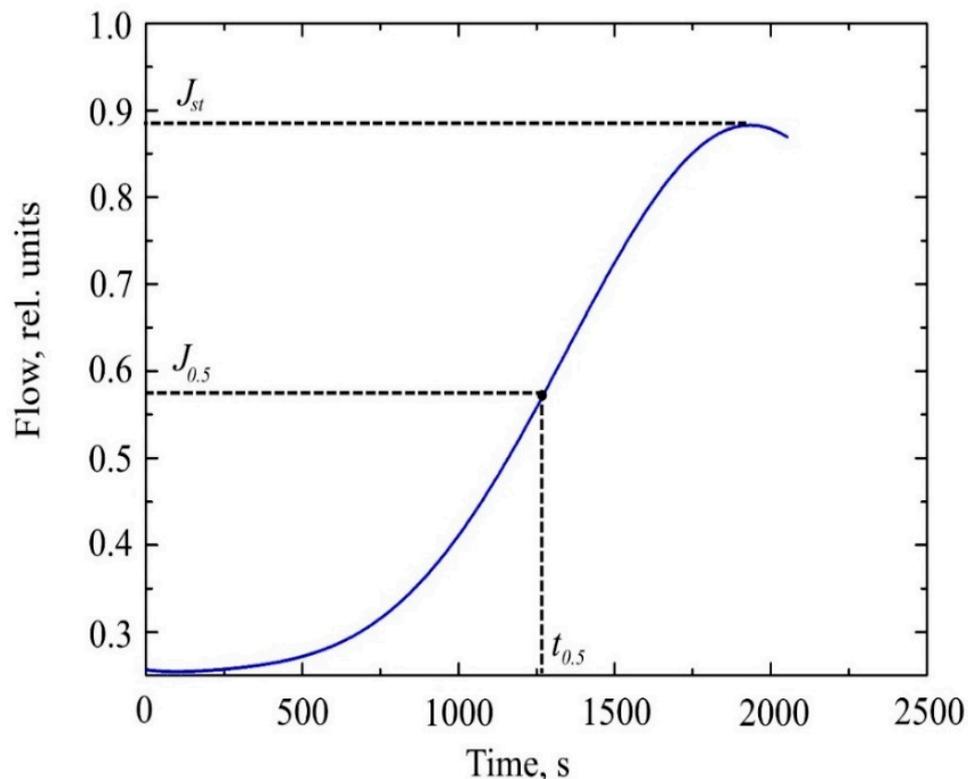
Figure 1. The curve of hydrogen permeability through a metal membrane.

$$D = \frac{l^2}{6t_{0.5}}, \quad (7)$$

where l is membrane thickness.

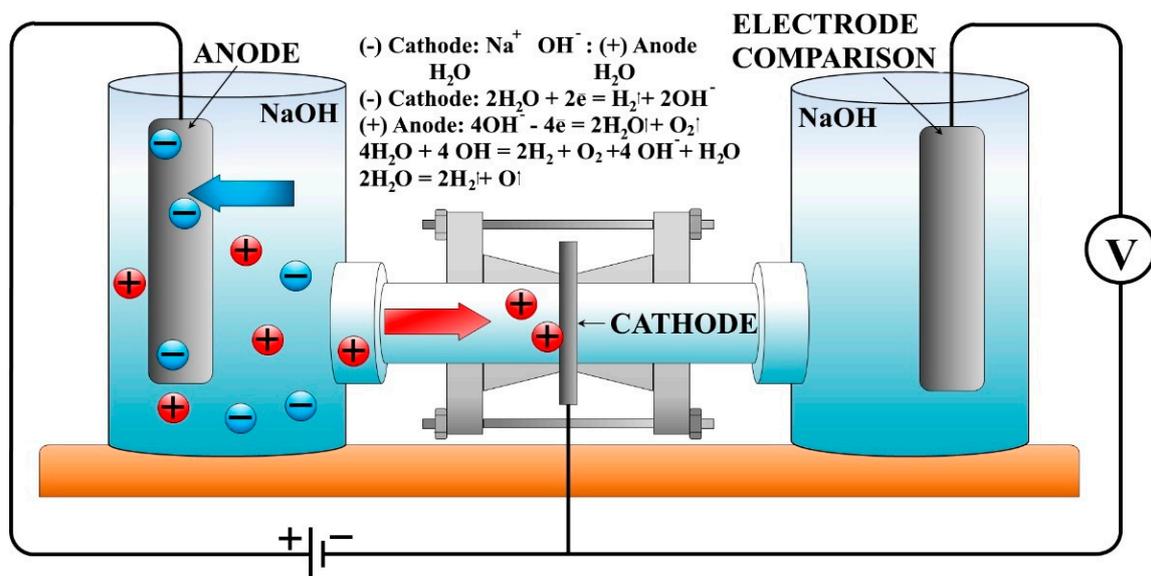
Figure 2. The processes of chemical reactions that occur during the electrochemical penetration of hydrogen ions through a metal membrane in a 20% solution of sodium hydroxide NaOH.

The chemical reaction processes taking place in this study at the STEP experimental bench in a 20% solution of sodium hydroxide NaOH are shown in Figure 2. The current density is selected to minimize the formation of gas bubbles on the sample surface. In this work, the current was approximately $\approx 300 \text{ mA/cm}^2$.

The passage of hydrogen ions through the material was determined by a change in the charge of the reference electrode in the near-surface region, as well as by a change in the chemical compositions of the near-surface region of the electrode during its interaction with hydrogen. The electrode potential of the surface of the sample and the reference electrode introduced into the cell was used as a measured, which makes it possible to judge the change in the charge state of the “output” region of the sample under study.

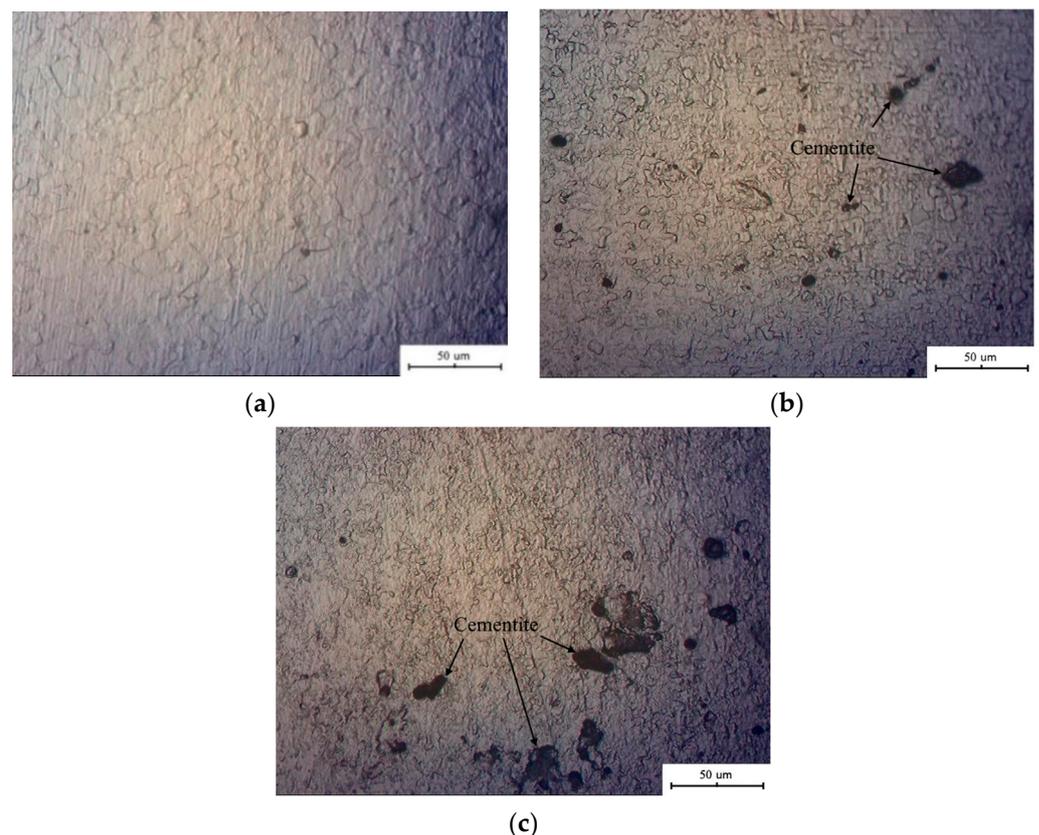
The microstructure was studied by ion etching of the surface in argon. As can be seen from Figure 3, the grain is crushed during aging. This is since during operation the pipeline material experiences variable loads due to fluctuations in the pressure of the pumped gas. Therefore, in the samples of series #0, the average grain size is $d = 8.9 \mu\text{m}$; and in the samples subjected to corrosion tests—4.8 and 4.1 microns for series #1 and series #2, respectively. Furthermore, in the process of aging, the formation of carbide-like inclusions of the secondary phase occurs. Since the formation of carbide-like secondary phases is limited to a greater extent by the diffusion process of mass transfer of carbon atoms, it can be noted that the number of such inclusions is directly related to the operating time.

Figure 3. Microstructure of the surface of steel grade 10G2: (a) steel in its original state; (b) steel after accelerated corrosion testing; (c) steel decommissioned.

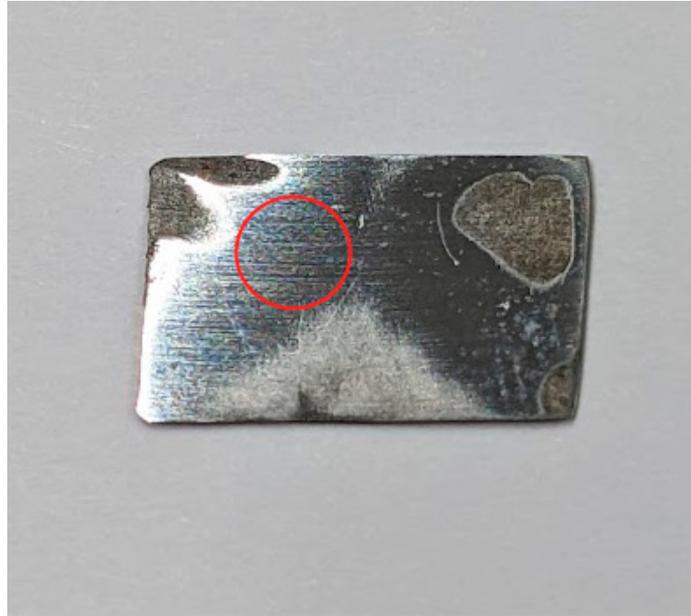
Figure 4 shows the studied initial sample of 10G2 steel (#1). This sample was cut from a natural gas pipeline. To analyze the sample using a scanning electron microscope, a relatively flat, undamaged surface area was selected.

Figure 4. Photo of the surface of a 10G2 steel sample. The area in which the observations were made using a scanning electron microscope is shown in red.

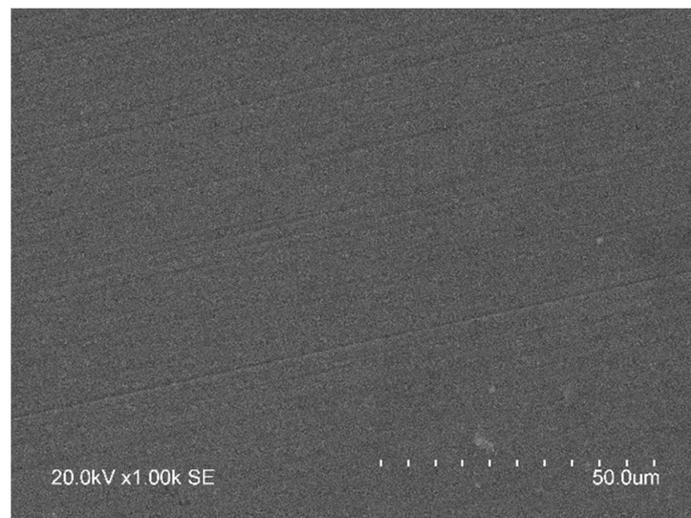
Figure 5. Micrograph of the surface of a sample of steel 10G2 (SE).

This micrograph shows that the sample surface is relatively flat. There are shallow, up to 2 μm in depth, traces left on the surface after the polishing procedure.

A micrograph of the surface of the initial sample of steel 10G2 is shown in Figure 5.

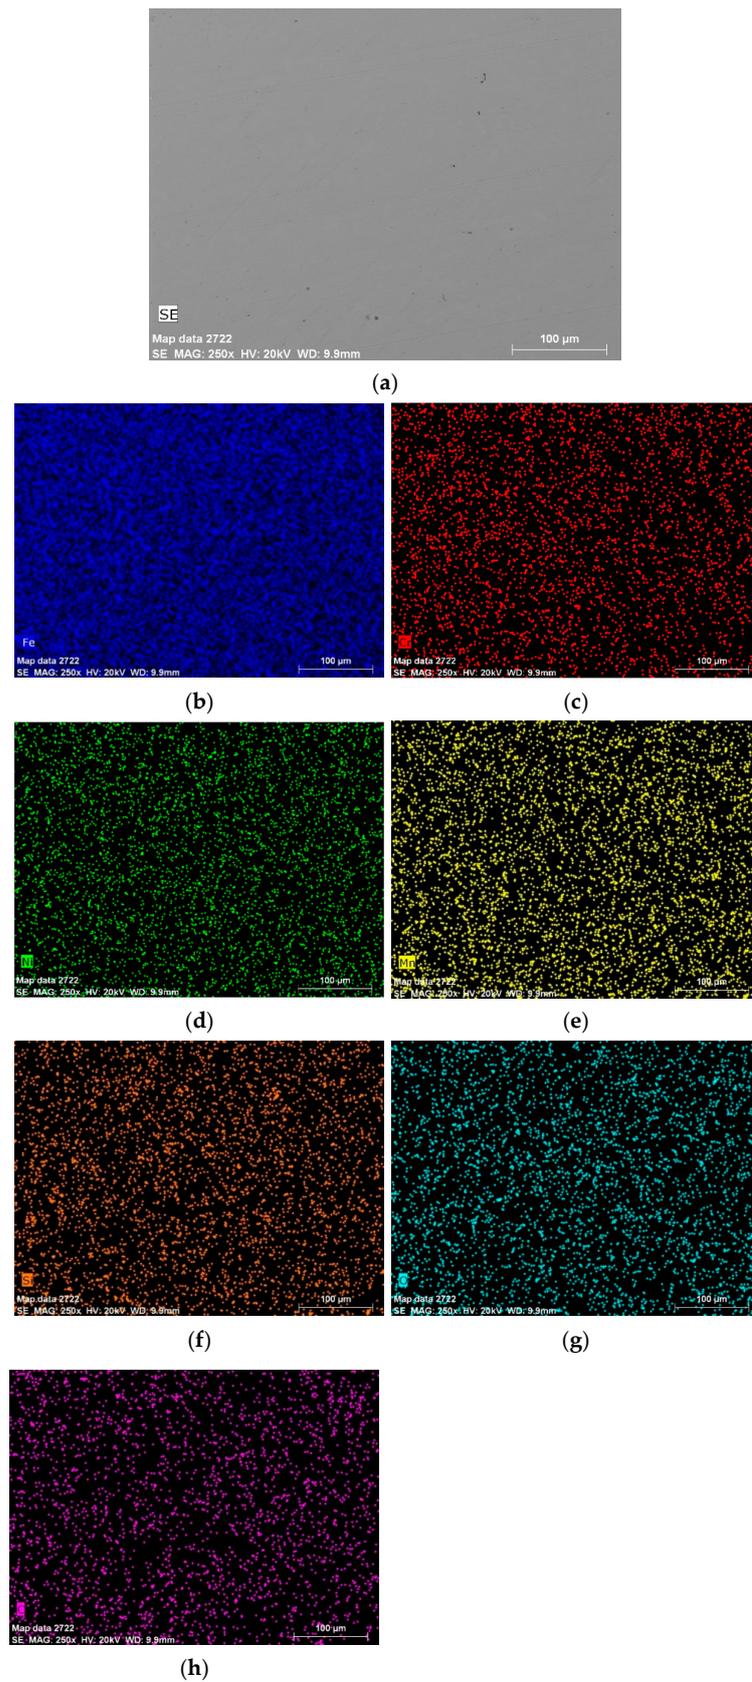
Figure 6. Micrograph of the surface of a sample of steel 10G2 (BSE) (a) and maps of the distribution of elements, (b) iron, (c) chromium, (d) nickel, (e) manganese, (f) silicon, (g) oxygen, (h) carbon.

Based on the micrograph of the sample surface, it can be concluded that the surface is homogeneous in composition. According to the maps of the distribution of elements, the sample corresponds to the chemical composition of steel grade 10G2 and consists of an alloy of iron, manganese, chromium and nickel. Oxygen (iron oxides and other substances) and carbon, which are surface contaminants, are present in small amounts. Silicon, which was found in small amounts over the entire surface during the study of this sample, was concentrated in some dark areas, which are a contaminant on the surface of the sample, as well as in a few voids. This contaminant may be nothing more than the residues of the cutting fluid used in the forming and testing of the pipeline.

A micrograph of the surface of the initial steel sample obtained by registering backscattered electrons, as well as maps of elements are shown in Figure 6a–h.

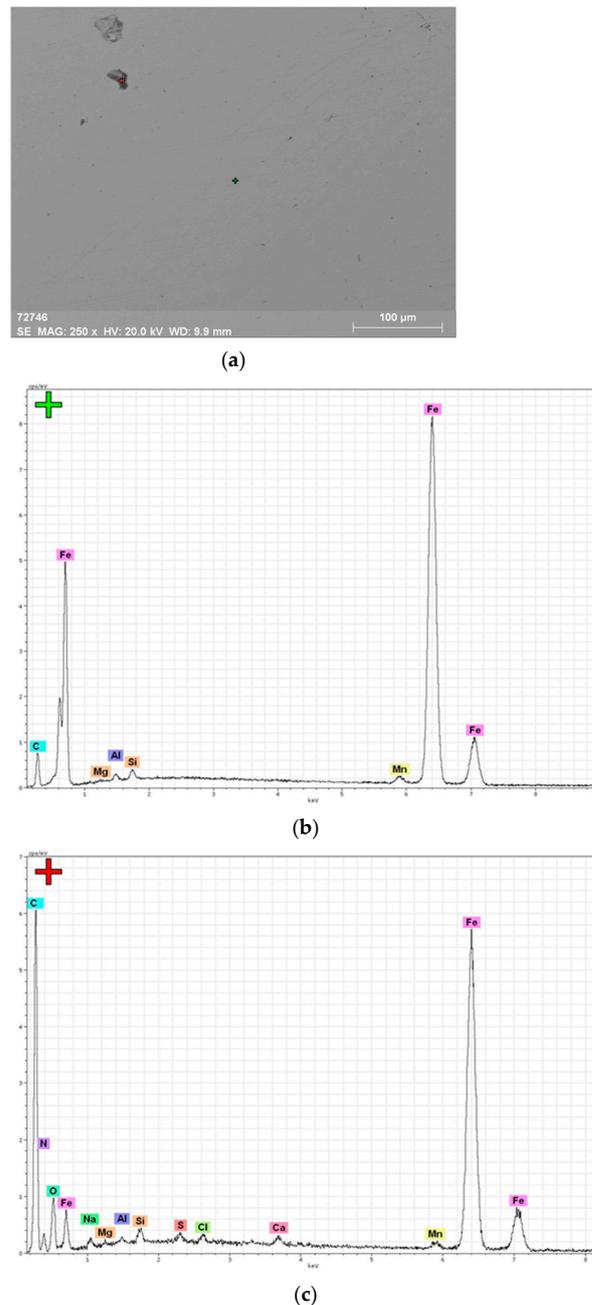
Figure 7. Micrograph (a) with EMF spectra (b,c) of the surface for a sample of steel 10G2.

The EMF results indicate that the sample surface does not contain any impurities, except for aluminum, which was recorded in an extremely small amount in the sample composition. The few dark areas on the surface that are associated with contaminants include carbon, oxygen, sodium, sulfur, chlorine, silicon and calcium.

Figure 7 shows a micrograph of the sample surface (Figure 7a) with spectra obtained by energy dispersive X-ray spectroscopy (EMF, Hitachi High-Tech Corporation, Kawasaki City, Japan) (Figure 7b,c).

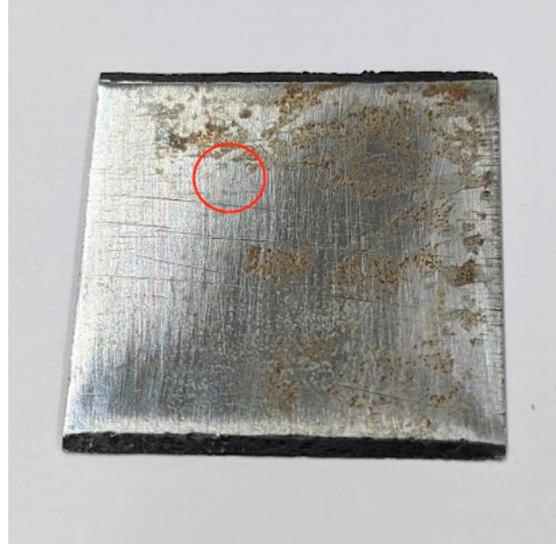
Figure 8 shows a photograph of the surface of a 10G2 steel sample exposed to the corrosive effect of a gas environment and moisture (#2). The observation was carried out in an uncontaminated area bordering the visually corroded area.

Figure 8. Photo of a 10G2 steel sample exposed to an aggressive humid gas environment. The area of observation is shown in red.

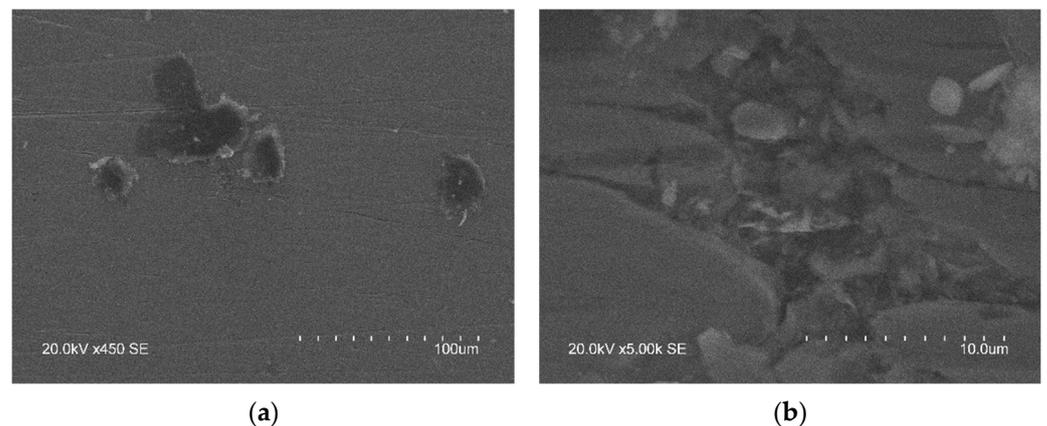
Figure 9. Micrograph of the surface of a sample of steel 10G2 (a), held in a humid atmosphere (SE) and the area of surface damage (b).

According to the above micrograph, there are traces on the surface after polishing. Corrosion precipitates and areas with damaged surfaces are observed, and such areas are observed over the entire surface of the sample.

Figure 9 shows a micrograph of the surface of a sample (Figure 9a) held in a corrosive environment of moisture and gas, as well as damage to the surface near the corrosion products (Figure 9b).

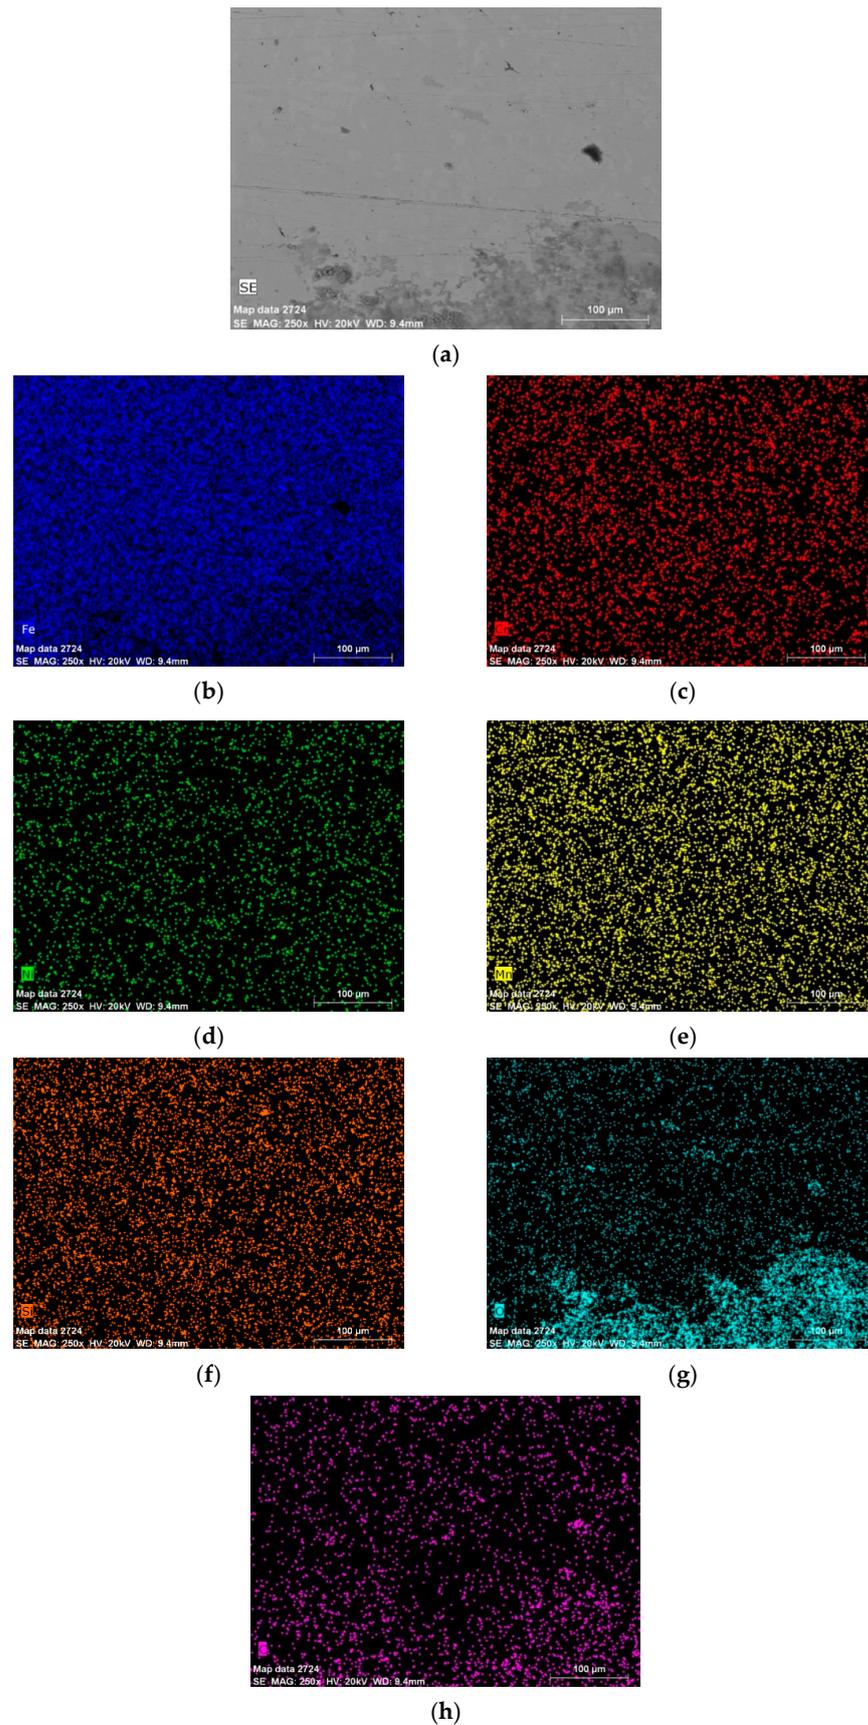
Figure 10. Micrograph of the surface of a 10G2 (BSE) steel sample (a) exposed to moisture and an aggressive gas environment, and a map of the distribution of elements, (b) iron, (c) chromium, (d) nickel, (e) manganese, (f) silicon, (g) oxygen, (h) carbon.

Based on the micrograph of the sample surface and the distribution maps of the elements, it can be concluded that the surface is heterogeneous in composition due to the numerous regions where Fe_2O_3 and Fe_2O_3 deposits (rust) are present. In these areas, there is an increased amount of oxygen and carbon, which is concentrated in the pores and voids that have arisen due to the aggressive effects of gas and moisture. In addition, even in areas without the release of corrosion products, numerous cracks, deep voids of small diameter and other damage are observed. The elements manganese, chromium and nickel are evenly distributed over the sample surface. Areas were observed in which a large amount of silicon is present.

A micrograph of the surface and maps of the distribution of elements for a steel sample, which was exposed to moisture and an aggressive gas environment, was obtained by registering backscattered electrons (Figure 10a–h).

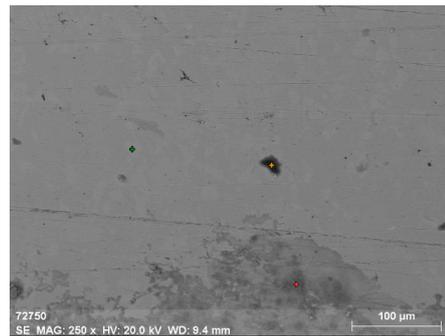
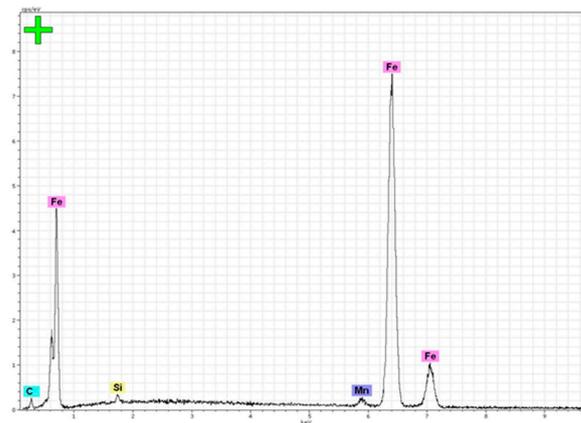
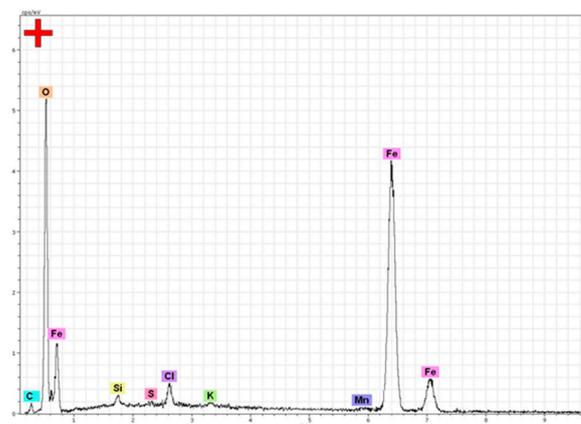
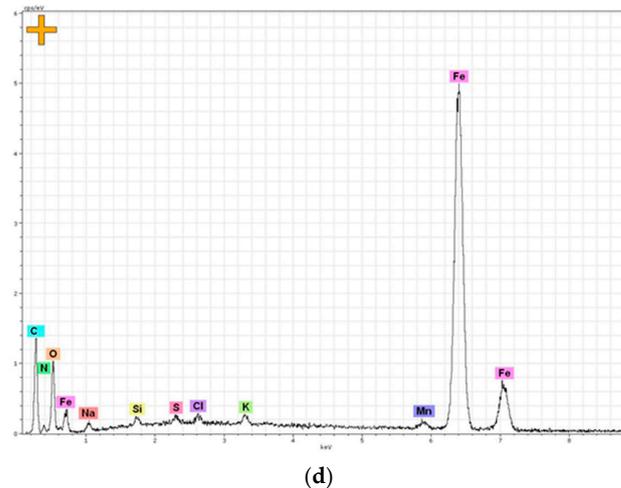
Figure 11. Micrograph (a) with EMF spectra (b–d) of the surface for a 10G2 steel sample exposed to moisture and an aggressive gas environment.

Based on the EMF results, it can be concluded that the sample surface does not contain any impurities. However, corrosion products are observed on the surface, consisting of iron oxides, as well as potassium and sodium. Contaminants are also present, including sodium, sulfur and potassium. Corrosion products consist of iron oxides and small amounts of potassium, silicon and sodium. It should be noted that chlorine, which is a well-known corrosion stimulant, has been found in corrosion products and in surface pollutants.

Figure 11 shows a micrograph of the sample surface (Figure 11a) with spectra obtained by energy dispersive X-ray spectroscopy (EDS) (Figure 11b–d).

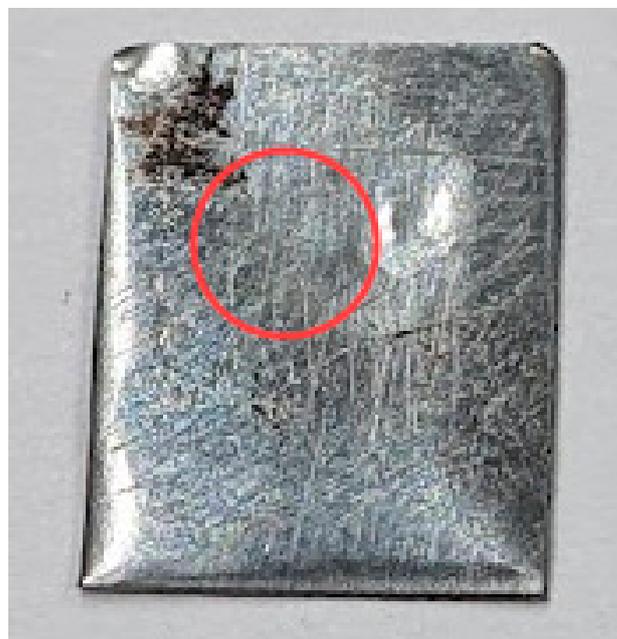
Figure 12 shows a photograph of the surface of a 10G2 steel sample cut from a previously operated gas pipeline (#3). The observation was carried out in a relatively unpolluted area.

Figure 12. Photo of a 10G2 steel sample cut from a previously operated gas pipeline. The area of observation is shown in red.

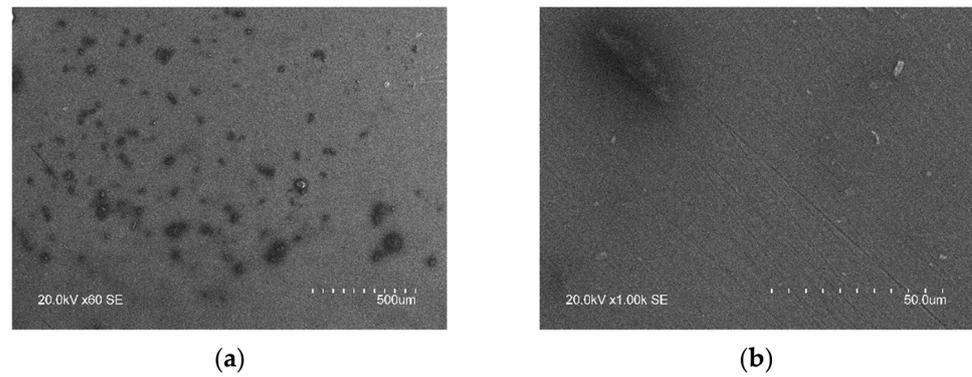
Figure 13. Micrograph of the surface of a 10G2 steel sample cut from a previously operated gas pipeline (SE) at 60 times (a) and 1000 times (b) magnification.

Based on these micrographs, the surface is heavily contaminated with foreign substances. There are traces of polish on the surface, as well as damage such as scratches, few pores and voids.

Figure 13 shows a micrograph of the surface of this sample at different magnifications.

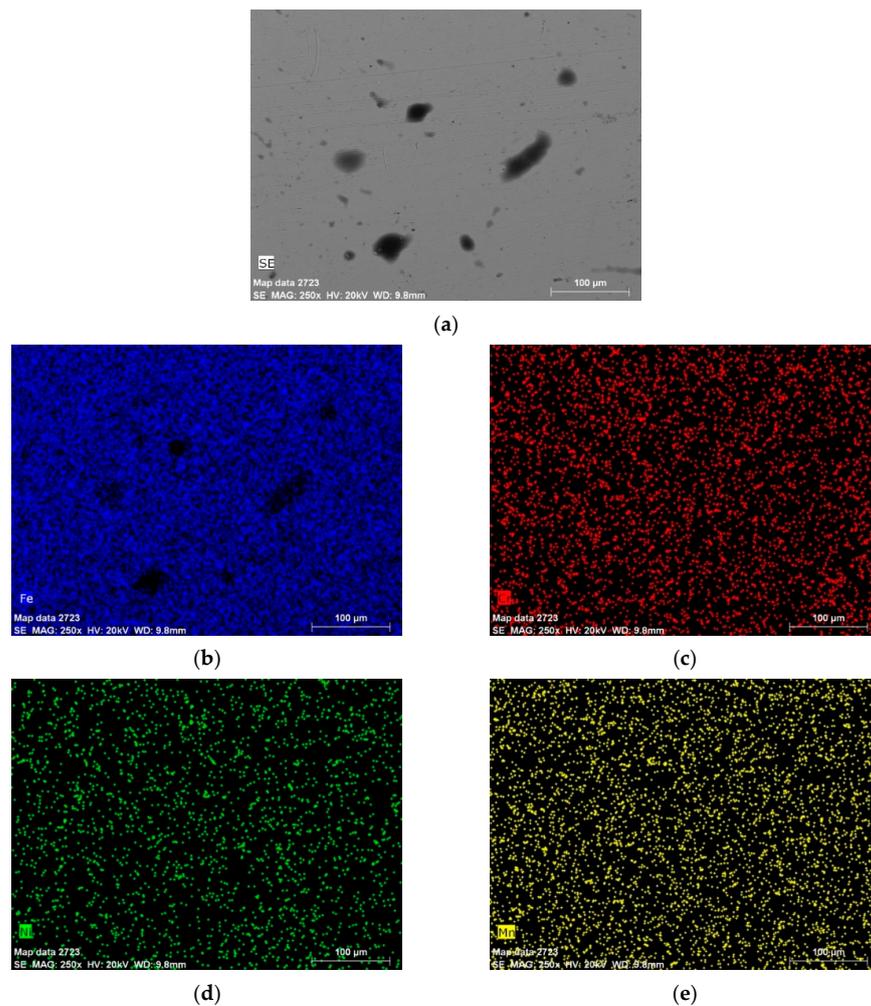
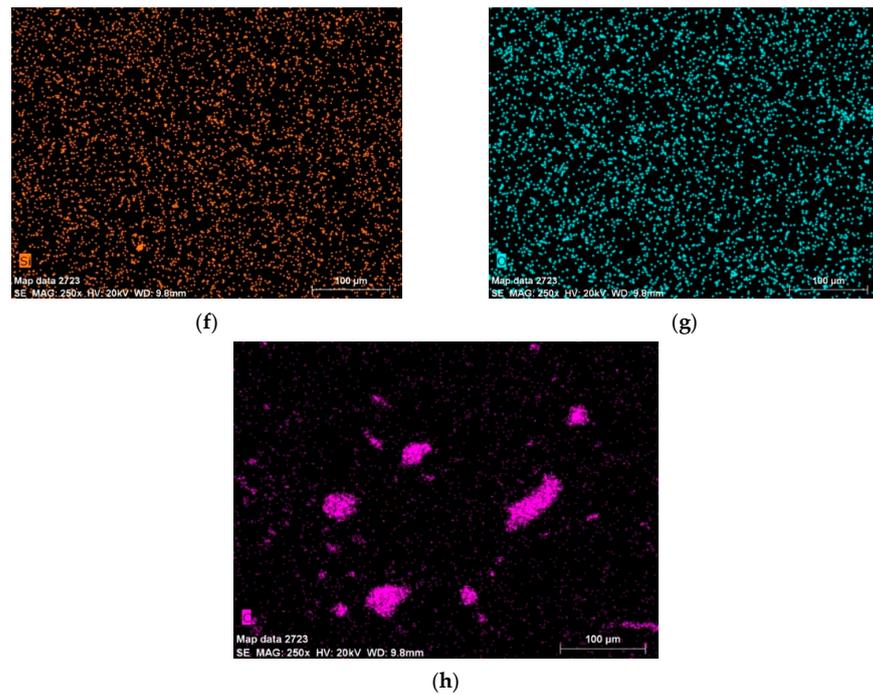
Figure 14. Micrograph of the surface of a 10G2 (BSE) steel sample (a) cut from a previously operated gas pipeline, and a map of the distribution of elements (b)iron, (c)chromium, (d)nickel, (e)manganese, (f)silicon, (g)oxygen, (h)carbon.

Based on the micrograph of the sample surface and the maps of the distribution of elements, it can be concluded that the surface is relatively homogeneous in composition, however, a large amount of polluting carbonaceous substances is present on the surface. The micrograph also shows small-diameter cavities. Alloying substances in steel are evenly distributed over the surface of the sample. Silicon has been found in small amounts in some areas with pollutants.

Figure 14 shows a micrograph of the surface (Figure 14a), obtained by registering backscattered electrons, as well as maps of the distribution of elements (Figure 14b–h).

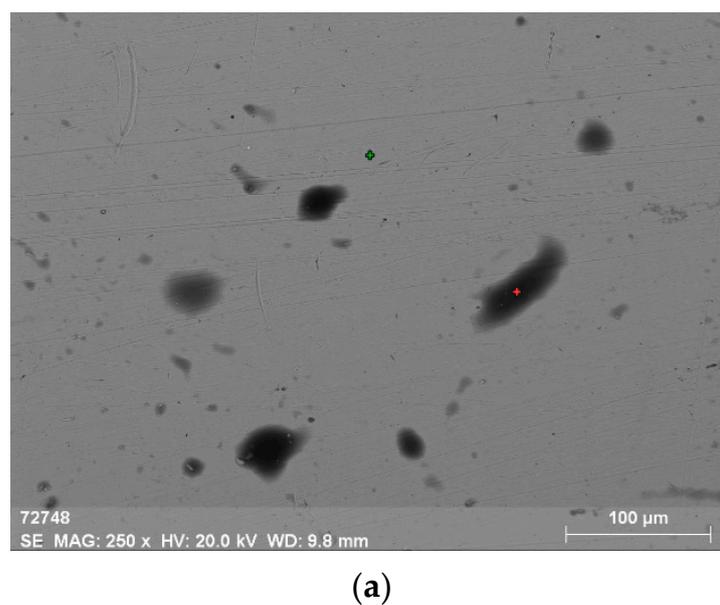
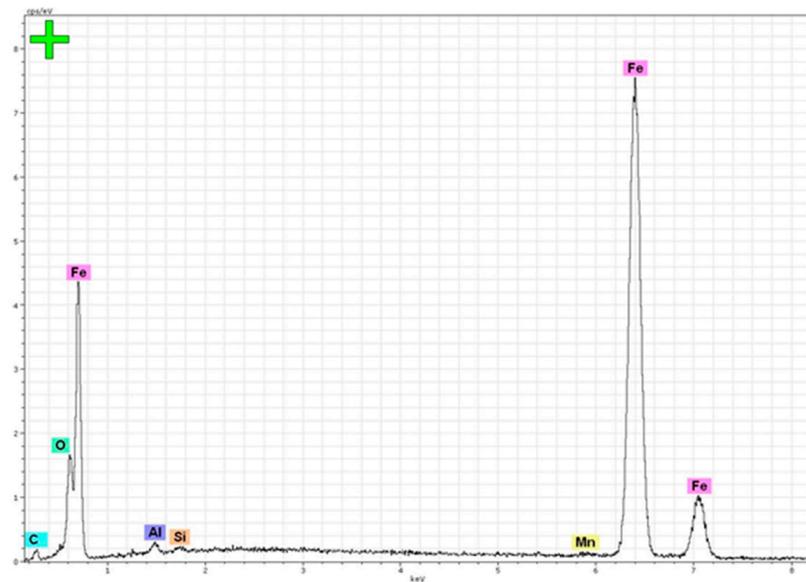
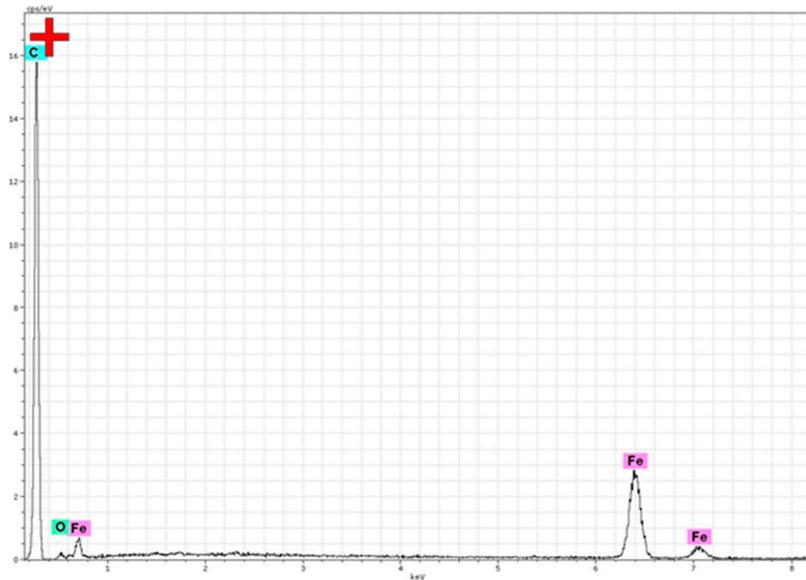
Figure 15. Micrograph (a) with EMF spectra (b,c) of the surface for a 10G2 steel sample cut from a previously operated pipeline.

Figure 15 shows a micrograph of the sample surface (Figure 15a) with spectra obtained by energy dispersive X-ray spectroscopy (EMF) (Figure 15b,c).

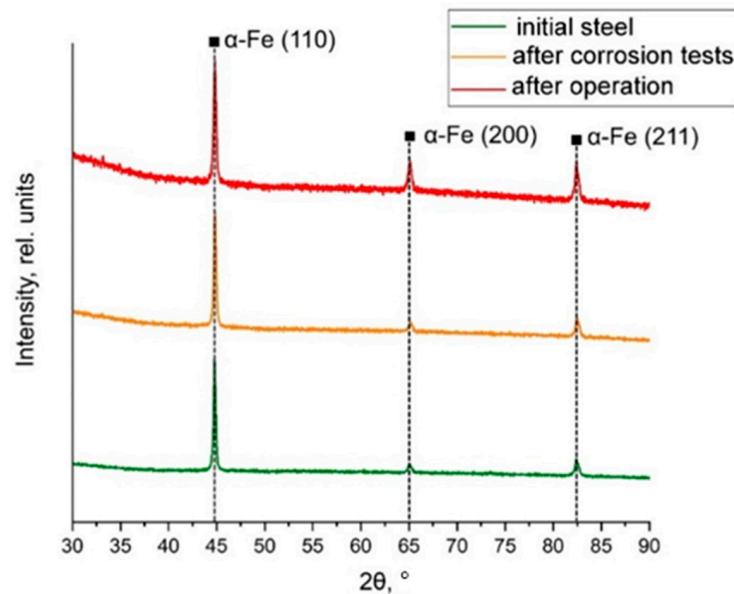
**Figure 16.** Diffraction patterns of a series of experimental samples of steel grade 10G2.

Analysis of the diffraction pattern of all samples shows the presence of only the alpha-iron phase with a body-centered cubic crystalline modification. Cell parameters are presented in Table 4.

Figure 16 shows the diffraction patterns for steel in its original state, steel after accelerated corrosion tests and steel decommissioning ambassadors.

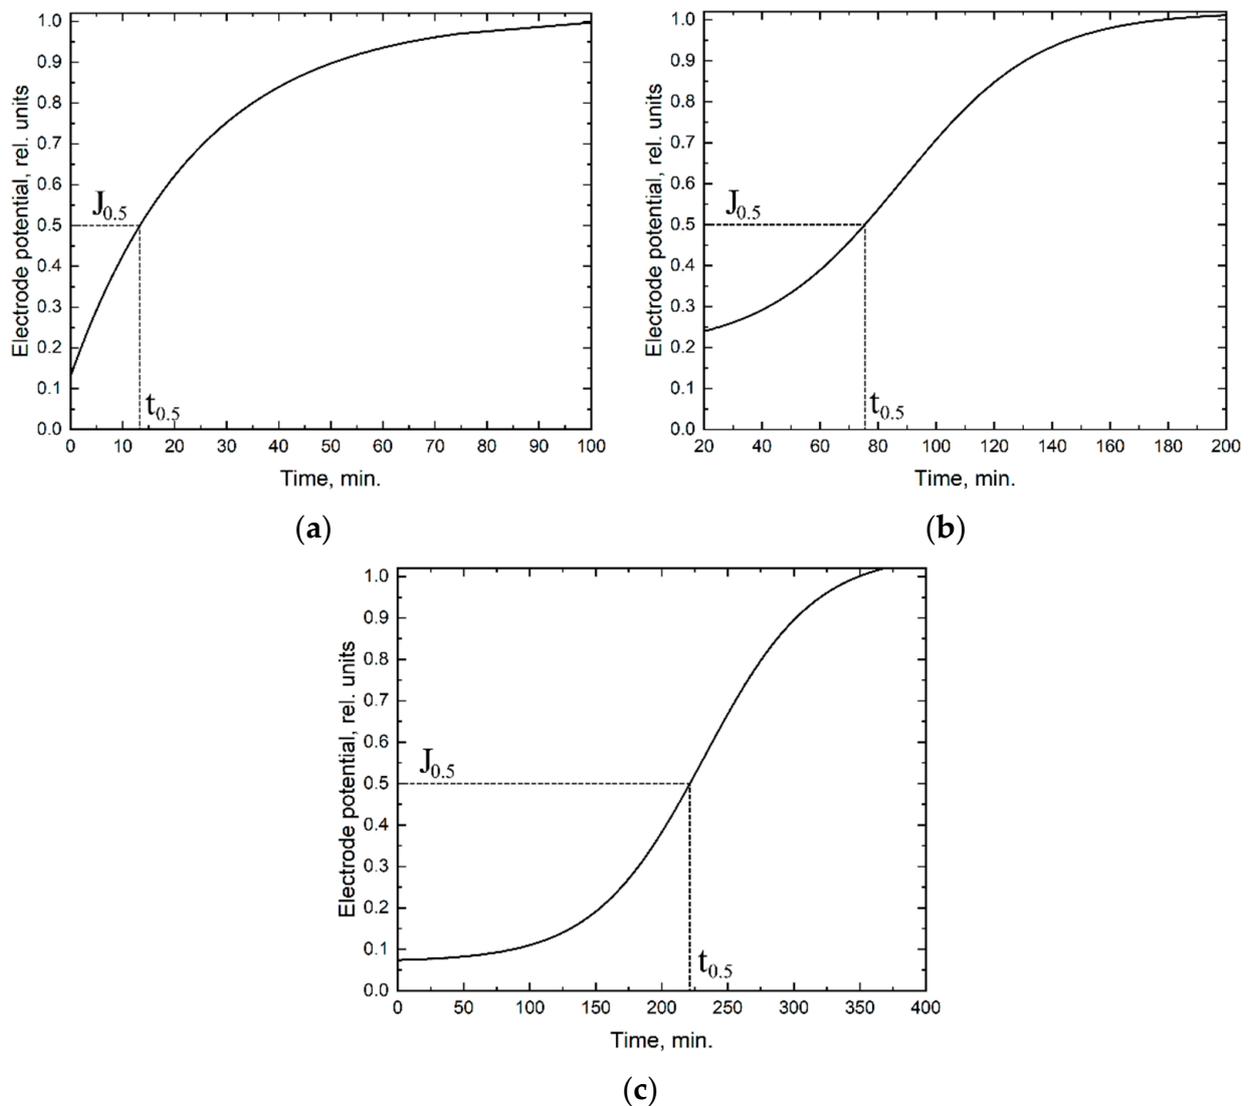
Figure 17. Hydrogen permeability curves: (a) steel in the initial state; (b) steel after accelerated corrosion testing; (c) steel decommissioned.

Using the previously described methodology for calculating the diffusion coefficient, the following data are obtained, presented in Table 5. The diffusion coefficient in the original steel lies in the range typical for this class of materials, which indicates the operability of

this methodology. The difference in diffusion coefficients in steels subjected to different operating parameters can be associated with the accumulation of many defects in the materials during operation. As is known, any defects in the crystal structure are hydrogen capture centers, which prevent the diffusion of hydrogen in the material.

The experimental samples were subjected to an experiment on the permeability of hydrogen with the following parameters: current density in the anode compartment $\approx 300 \text{ mA/cm}^2$; experiment time is 22 h. The resulting permeability curves are shown in Figure 17.
