Article

Change in the Properties of Rail Steels during Operation and Reutilization of Rails

Abstract: The paper considers the possibility of reusing previously used railway rails. The analysis is conducted using the standards and operating conditions of the rails of one of the Central Asian states, Kazakhstan, as an example. The operation of these rails causes significant stresses, while the surface layers are strengthened as a result of cold hammering. These phenomena significantly change the physical and mechanical characteristics of rails. As a result, they may not be suitable in terms of parameters for basic use but can be suitable for installation on other tracks. The conducted studies have shown that when the standard service life of the RP65 rail expires, the surface layer is deformed to a depth of up to 300 microns, hardness increases, and internal residual stresses are formed. These changes lead to an increase in the strength properties of the rails. However, at the same time, cracks originate in the surface layer of the rail, thus worsening operational characteristics. The RP65 rails are used under a cyclic load of 700 kN (which is determined by the national standard),

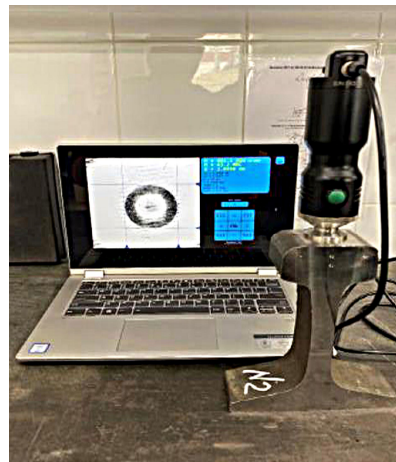
Figure 1. Measuring the hardness of the samples with the WILSON BH3000 hardness tester.

The hardness of the rolling head surface was determined as follows: The rail's hardness was monitored using a Brinell device. The hardness of the surface and cross section of the rail was determined by a WILSON BH3000 (ITW Test & Measurement GmbH, Duesseldorf, Germany) hardness tester according to GOST 9012-59 (Figure 1). The spot for determining the hardness of the rail's rolling surface was cleaned to remove scale and a decarbonized

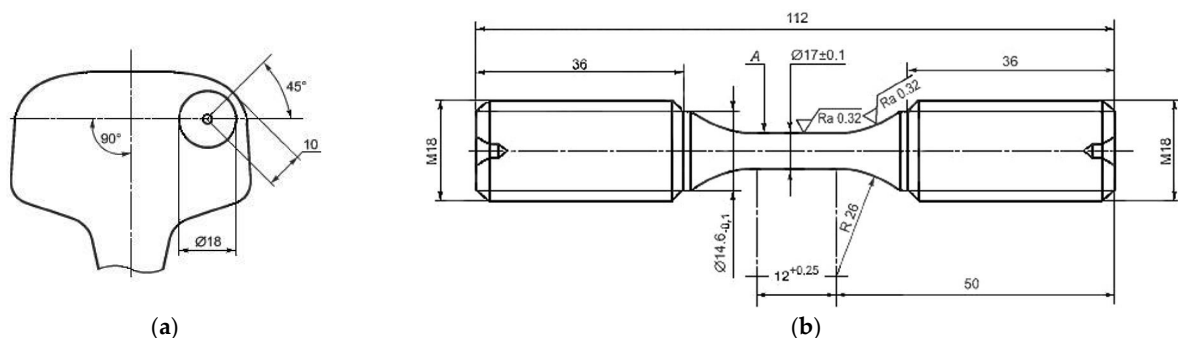
Figure 2. The spot where the samples for tensile testing were cut and the sample dimensions. (a)—the place where the sample was cut from the rail, (b)—test specimen drawing.

The mechanical tension properties of the rail were determined using the Instron HDX-1000 universal rupture test machine. The blanks of samples for the tensile test were cut along the rolling direction taken from the upper part of the head in the fillet zone as close as possible to the surface at a distance of at least 150 mm from the end of the rail (Figure 2). The main dimensions of the samples are also shown in Figure 1. The mechanical characteristics were recorded automatically and calculated by the control and calculation software of the test machine. The measurement error of this machine is $\pm 0.5\%$. Tensile strength mechanical characteristics were determined according to the uniaxial tension scheme on the cylindrical samples (Figure 2), which had a pick-up movement rate of 10 mm/min.

of the rail (Figure 2). The basic dimensions of the samples are also shown in Figure 1 (Loading scheme—cyclic tension-compression). Cyclic durability tests were conducted indoors at an ambient temperature of 22 °C and a relative humidity of 65%. The samples had a temperature of 22 °C before the tests. A longitudinal uniaxial cyclic load was applied to the sample, which had a loading cycle asymmetry coefficient of minus 1 and a loading frequency of 40 Hz. The test base is 5 million loading cycles. The testing was terminated when a crack or fracture in the sample formed or when the test base was reached.

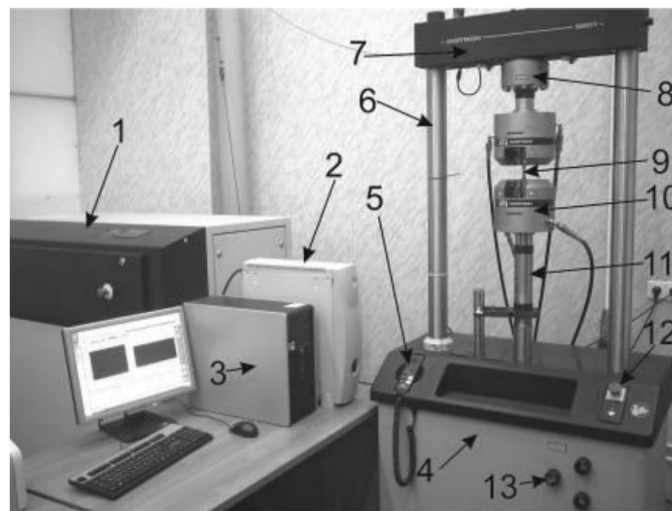
Figure 3. Appearance of the test complex, Instron 8801. 1—hydroelectric power station, 2—controller, 3—computer, 4—power frame, 5—control panel, 6—columns, 7—rigid horizontal traverse, 8—force action sensor, 9—sample, 10—hydraulic grips, 11—hydraulic servo drive column, 12—panel for controlling the hydroelectric station, and 13—valves for controlling the stiffening beam position.

The cyclic life during fatigue tests is determined according to GOST 25.502 under hard loading (strain control) of the samples with a constant amplitude of the full strain (longitudinal) equal to 0.00135. Cyclic durability tests were performed using the Instron 8801 (Instron Engineering Corporation, Norwood, MA, USA) universal machine (Figure 3). This machine has built-in sensors for measuring the deformation value. Sample blanks for the test were cut along the rolling direction from the upper part of the head in the fillet area as close as possible to the surface at a distance of at least 150 mm from the end

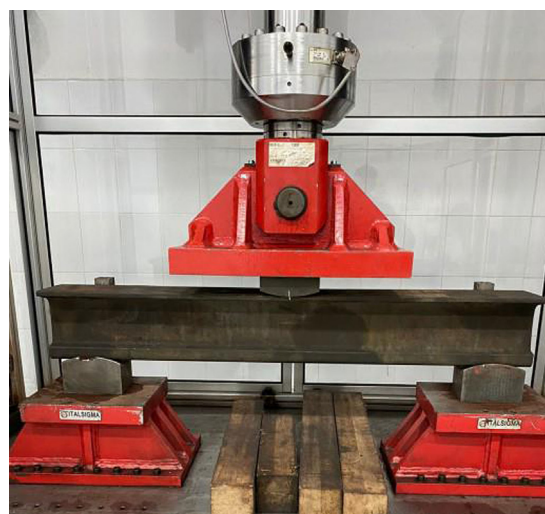
Figure 4. Experimental plant and a general view of tests for determining the endurance limit of the rails.

The tests were carried out on full-profile samples (1200 + 10 mm long), cut from the rails by cold mechanical cutting methods. The loading scheme is a flat three-point symmetric bending (Figure 4). The distance between the lower supports is 1000 ± 5 mm. The upper punch is installed in the middle between the supports within 500 ± 5 mm. The samples are tested under soft loading (force control) in the position “head down” of the rail when the asymmetry of the loading cycle is plus 0.1. The test base is 2 million cycles.

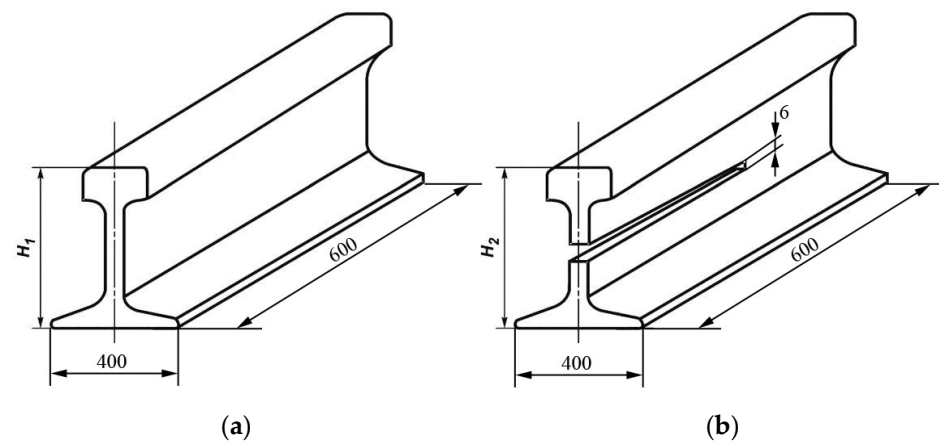
Figure 5. Schematic of residual stress control in a track neck. (a)—rail before testing, (b)—rail after cutting for residual stresses testing.

Residual stresses in the rail neck are determined by the divergence of the groove as a rail height difference ($H_2 - H_1$) along the axis at the end of the sample before and after cutting the groove according to the scheme shown in Figure 5. The samples intended for studying residual stresses by the mechanical method were prepared on an electrochemical die-sinking and hole-contouring machine, SFE-12000M (STANKOFINEXPO, Kirov, Russia). Such equipment was chosen because no additional technological residual stresses were introduced when using this method of preparing experimental samples. Initially, a piece of the rail having a length of 600 ± 3 mm was cut off, and then a groove 6 ± 1 -mm wide was cut through, and the accuracy of this size was ensured by the accuracy of manufacturing with an electrode tool.

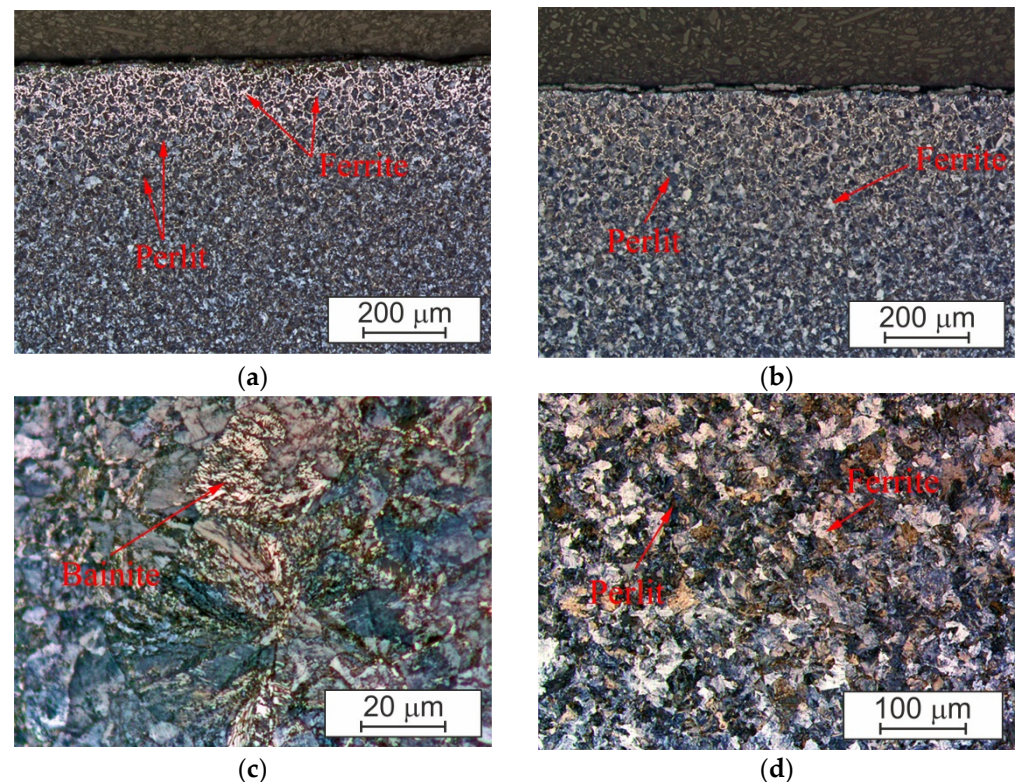
Figure 6. Microstructure of the studied R65 rails: (a) surface of the rail after the standard service life of 494 million t-km gross; (b) new (unused before) rail in a state of delivery; (c) pearlite grain on the rail surface after the standard service life; and (d) ferrite-pearlite structure section of the rail surface after the standard service life (at a depth of ~3 mm from the surface).

First, the microstructures of already-used and new rails were studied. The photos of the etched microstructure of the used R65 rails and the new R65 rails are shown in Figure 6.

The metal microstructure of the rails after operation is represented by a lamellar pearlite estimated at 2–3 points (0.3–0.4 microns) with scattered ferrite sections along the grain boundaries. The number of ferrite grains present in the used R65 rails (Figure 6d) is less than 5%, and the average size is about 0.24–0.26 μm . There is practically no pearlite in the new R65 rails (Figure 6b), and bainite was not detected in the microstructure of the studied rail. When moving away from the surface of the rail rolling head, pearlite acquires a more coarse-grained structure. This is related to the specificity of rail manufacturing technology. The rails taken for this study were made by hot rolling. Since the rail cools unevenly after rolling, a finer-grained structure is formed on the surface; however, when moving away from the surface of the rail head, the pearlite grain size becomes larger. Characteristic images of this structure with a larger grain are shown in Figure 6d.

A deformed structure is observed to a depth of up to 300 microns on the etched cuts from the surface of the working fillet. The amount of the decarbonized layer on the surface identified by the solid ferrite grid does not exceed 320 μm (Table 2). Local light-etched areas of a work-hardened metal are observed on the rolling surface, along which cracking develops (Figure 6a).

The metallography of etched cuttings (Figure 6d) revealed that structurally free ferrite grains are present in the steel structure of the used rails, i.e., ferrite grains, in the volume of which there are no carbide phase particles. The relative content of such grains is small and does not exceed 5% of the steel structure. Ferrite grains, as a rule, are located in the form of interlayers along the borders of pearlite grains (Figure 6a) or at the joints of the borders of pearlite grains (Figure 6d).

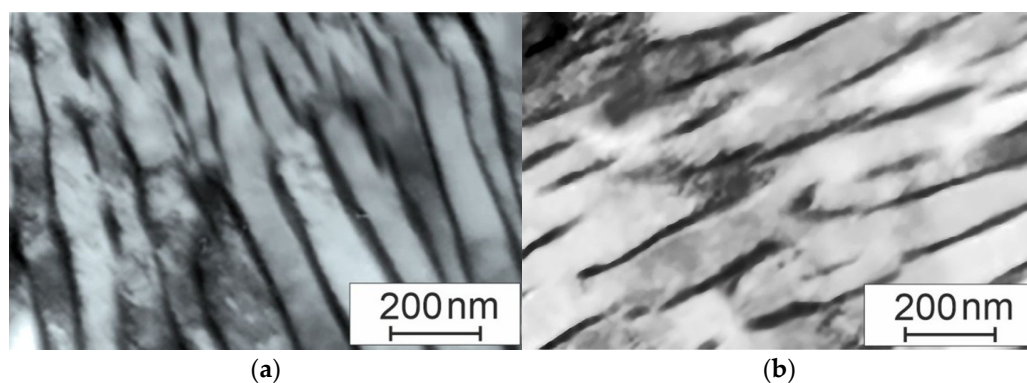
Figure 7. Pearlite structure in the surface layer: (a) alternating pearlite structure and (b) broken structure of cementite plates.

According to the classical definition, pearlite is a structural component of steel and cast iron, a eutectoid mixture of ferrite and cementite [20]. When crystallized under normal conditions, pearlite has a lamellar structure consisting of alternating plates of pearlite and cementite [21]. The studies performed in the present work revealed numerous imperfections in the structure of lamellar pearlite, namely, an alternating “comb” type structure (Figure 7a) and breaks of cementite plates (ferrite bridges) (Figure 7b). Quite often, there are curved plates of cementite of varying thickness in the pearlite colony.

The ferrite plates of pearlite colonies quite often have an alternating light and gray contrast. This diffraction contrast indicates that the ferrite plates are obviously divided into weakly misaligned areas as a result of elastic stresses.

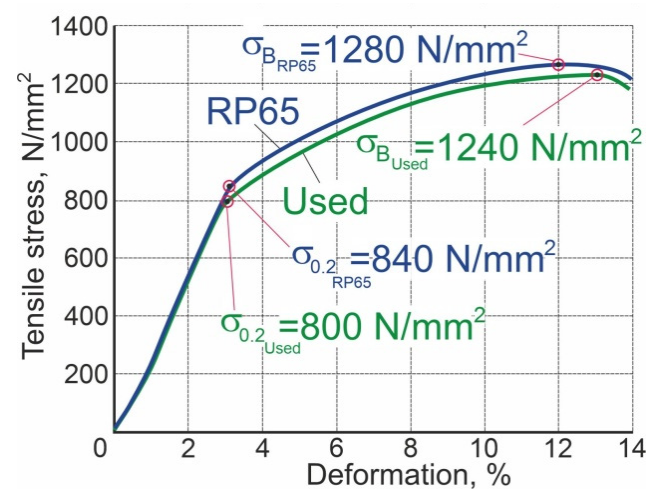
Figure 8. Tensile diagram for the studied samples cut from R65 and RP65 rails.

The studies of the mechanical properties of the rails showed that there was a slight difference in the values of the strength limits and the plastic characteristics of the new RP65 rails and the previously exploited R65 rails (Table 4, Figure 8). The obtained results demonstrated that the strength properties (σ_B) for the material of the previously used R65 rails are 40 MPa lower than those of the material of the new RP65 rails. However, at the same time, the plastic properties of R65 are higher by about 8.5%. This can be explained by an appropriate combination of factors. On the one hand, the previously used rails have larger stitch defects, which should lead to a decrease in plastic properties. On the other hand, the initial chemical composition of R65 contains less sulfur and phosphorus.

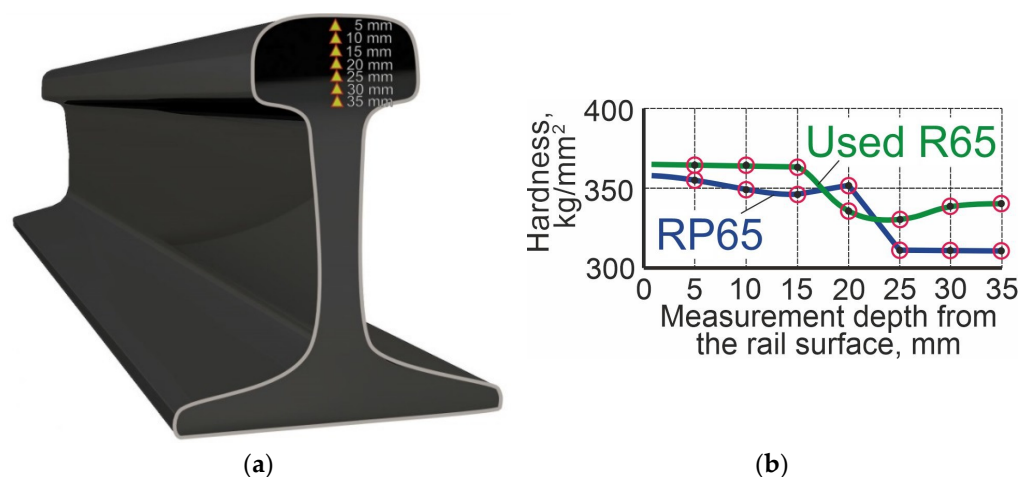
Figure 9. Hardness measurement: (a) schematic of hardness measurement and (b) dependence of hardness on the distance from the rail surface.

The diagram of hardness measurements along the rail section is shown in Figure 9.

Long-term operation of rails is usually accompanied by deformation and transformation of the material structure [22]. This can be justified by the hardness values obtained for the operating rails. The upper hardness limit is HB401 for the R65 rails. The hardness at a distance of 10 and 22 mm from the rolling surface must be 345–360 (HB_{10 mm}) and 325–350 (HB_{25 mm}). The hardness of the studied rails is within the upper boundary of these values or exceeds them, and the property changes are consistent with the changes in the rail structure. The quantitative analysis of the morphological state of the steel structure performed in this work showed that the operation of rails is accompanied by the transformation of the state of lamellar pearlite grains, namely, the destruction of cementite plates. According to the photographs in Figure 6, regardless of the position of the material's analyzed volume (rolling surface or fillet surface), the destruction of the lamellar pearlite structure is at its maximum in the surface layer of the rails, with a thickness of less than 2 mm. However, the destruction degree of the lamellar pearlite structure depends substantially on the position of the volume to be analyzed; namely, on the rolling surface, the relative content of the broken pearlite grains is more than 2 times higher than the content in the surface layer of the working fillet.

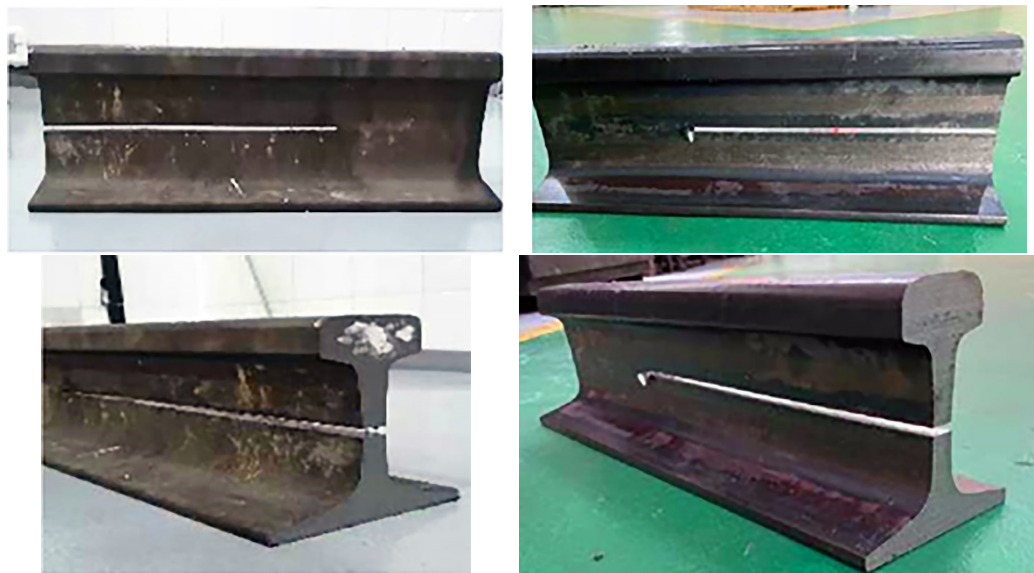
**Figure 10.** Samples after residual stress control in a rail neck.**Table 9.** Analysis of test results for determining residual stresses in the middle part of the rail base.

The studies of the hardness along the cross section of the used rail show that the changes in properties can be considerable. Hence, the rolling of the wheel on the surface of the rail not only causes changes in hardness but can also form residual stresses at a considerable depth. The testing of the samples to determine residual stresses showed that there are considerable differences in values for the new and already used rails (Table 8). Residual stresses in the neck of the used rails are 1.42 times higher than those in the new rails (Figure 10). However, the stress values are in the upper range of values allowed for 2 mm rail use. A similar situation is observed for the middle part of the rail base. The residual stress level for the used rails is 1.25 times higher than that for the new ones (Table 9). In addition, the residual stresses of the used rails lie in the upper range of permitted values for use. Such differences in voltage values are certainly related to the operating conditions of the used R65 rails. Rolling the wheels of railway trains under a significant load deforms not only the surface layer but also the rail. This, in turn, determines the appropriate level and nature of the distribution of residual stresses. In the new rails, small residual stresses are formed at the manufacturing stage. Since the rails are made by hot rolling, internal stresses are formed in them [22].

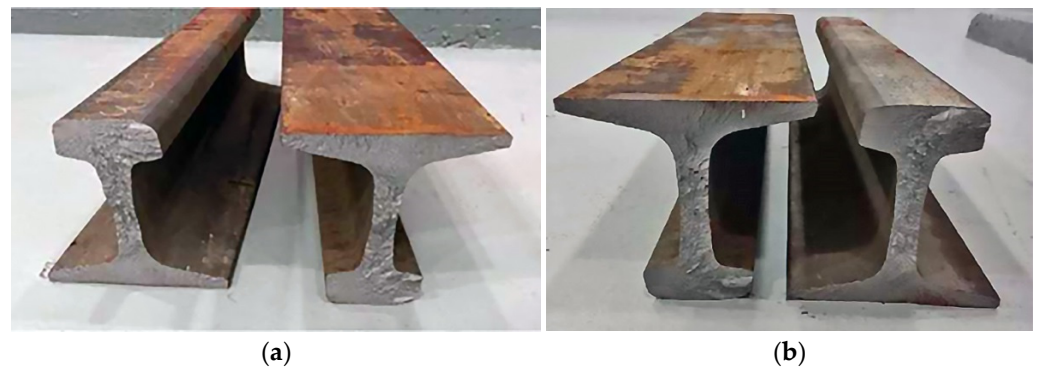
Figure 11. Rail failure after cyclic tests: (a) under a load of 700 kN, number of cycles: 790,056; (b) fracture under a load of 600 kN, number of cycles: 1,111,966.

The normalized values for using the rails in Central Asia are 2,000,000 cycles under a load of 700 kN for rails R65 and RP65. The new rails certainly meet these requirements (Table 10). In the case of the previously used rails, the maximum load under which they could operate for 2,000,000 cycles was 510 kN. Under a standard load of 700 kN, the used rails can only withstand 790,000 cycles (Figure 11a).

This result is largely due to the formation of cracks in the surface layer of the rails. A photograph of the fracture surface (Figure 11a) shows that the fracture originated on the side surface of the rail. The reason for the crack development was the zone of lateral collapse of the rail head formed under operating conditions (Figure 12a). This crack nucleus led to its fatigue development. Figure 12a clearly shows the zone of stable fracture development. It is characterized by fatigue lines representing approximate concentric contours. The focus of these contours is at the origin of the fatigue crack (Figure 12b). The surface of this zone is smooth and level. This effect is the result of cold hammering caused by repeated presses of two surfaces of the crack on each other.

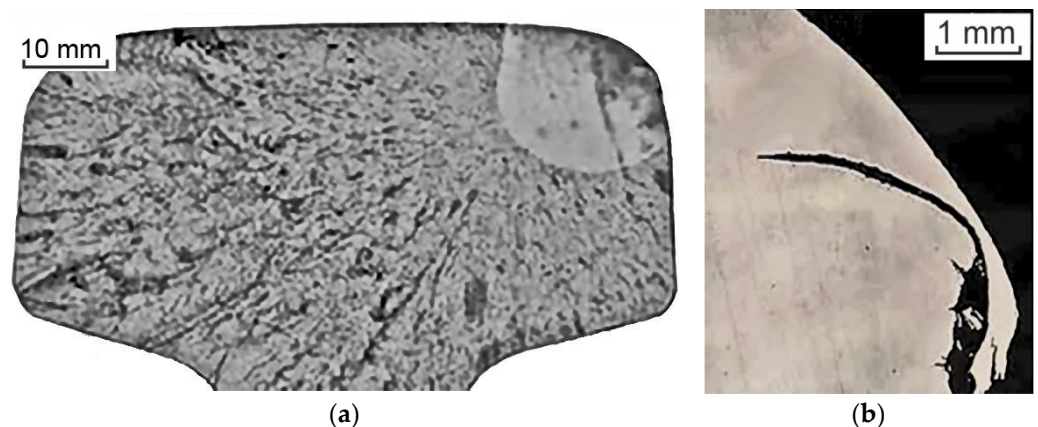
Figure 12. Failure of a used rail after endurance limit tests. (a) A general view of the rail head and (b) the place where the crack originated on the rail fluting.
