# Analysis of the opportunities for improving energy efficiency in public buildings

**Abstract.** Reducing energy consumption and maintaining an appropriate indoor air quality in buildings is a global trend. This is achieved in several ways – improving the building envelope thermal characteristics; fuel base replacement; introduction of smart energy consumption tracking systems. The aim of this paper is an analysis of the impact of energy efficiency measures introduced in buildings that provide health services. Measures have been taken to improve the energy performance of the envelope, as well as to modernize the system for the production and distribution of thermal energy. One complete year after energy savings measures implemented the total energy savings of 37.9% have been achieved. Further economic assessment has been made regarding the profitability of the applied measures.

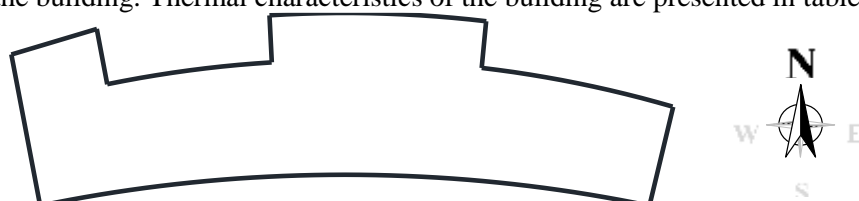
**Figure 1.** Scheme of the building.

The first building is the Fthysiatic ward. The building is public state-owned and was built in 1889. The surveyed part of the hospital is a brick building with a monolithic structure. The facades are lime-cement plaster in a relatively good condition. The exterior walls are masonry of solid bricks with different thickness without thermal insulation. The building is equipped with contemporary aluminum frames with double glazed windows. The roofs are tiled without thermal insulation, with the same height throughout the attic spaces. The floors of the building are made of concrete slab without thermal insulation with laminate and terracotta coating. All parts of the building are heated. The working regime of the hospital is 24 hours and 7 days a week. Figure 1 shows the design and orientation of the building. Thermal characteristics of the building are presented in table 1.

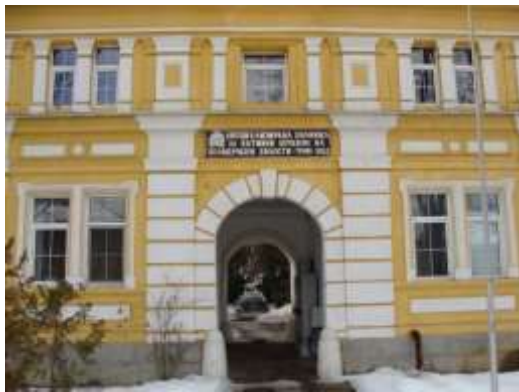
**Figure 2.** View of the hospital administration.

The building is public state-owned, built in 1889 and used as Administration. The surveyed part of the hospital is a brick building with a monolithic massive structure. The facades are lime-cement plaster, in a relatively good condition. The outer walls are masonry of solid bricks of different thickness without thermal insulation. The building is equipped with contemporary aluminium frames with double glazed windows. The roofs are tiled without thermal insulation, with the same height throughout the attic spaces. The floors of the building are made of concrete slab without thermal insulation with wooden flooring (laminated) and terracotta. All parts of the building are heated. An outline of the building is presented in Figure 2.

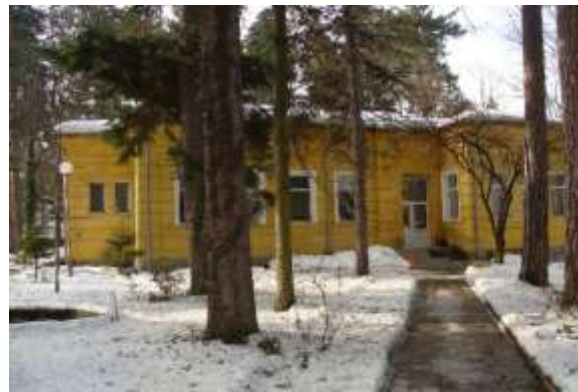
**Figure 3.** View of pneumology 1 hospital building.

The structure of the building is similar to that of Building 2. A general view is presented in Figure 3.

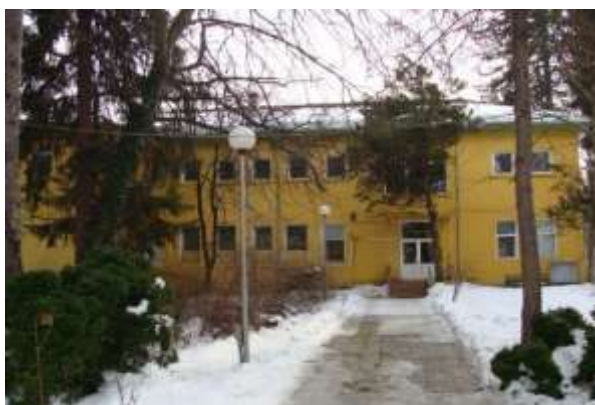
**Figure 4.** Scheme of the building.

The structure of the building is similar to that of Building 2. A general view is presented in Figure 4.

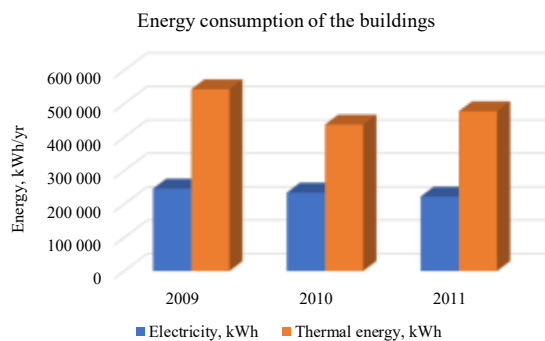
**Figure 5.** Yearly annual energy consumption of the buildings.

Table 5 and Figure 5 show the energy consumption by years for the period, as well as the number of heating day degrees. From Figure 5 it is evident that the share of electricity consumption during the surveyed period is between 31% and 35% and the consumption of the thermal energy – 65–69%.

Figure 4 presents the energy consumption in the buildings for the period 2009–2011. The difference in consumption is no more than 15% and depends mainly on the use of the available equipment as well as the external weather conditions.

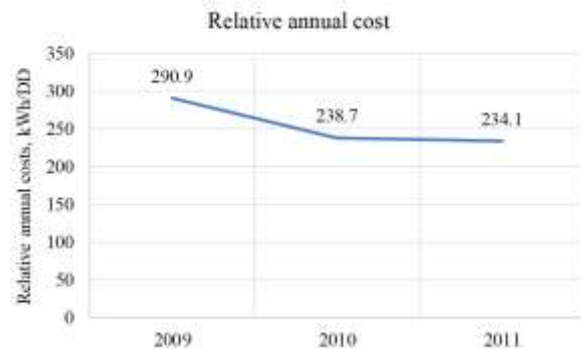
**Figure 6.** Relative annual costs, kWh/DD.

The relative annual energy consumption, as shown in Figure 6, is calculated based on this data. It is clear that the relative annual energy costs do not significantly change over the last two years and are less than the costs in 2009. This is due to the fact that in 2009, there has been a replacement of the window frames of the building, as a result of which the specific energy consumption has decreased.

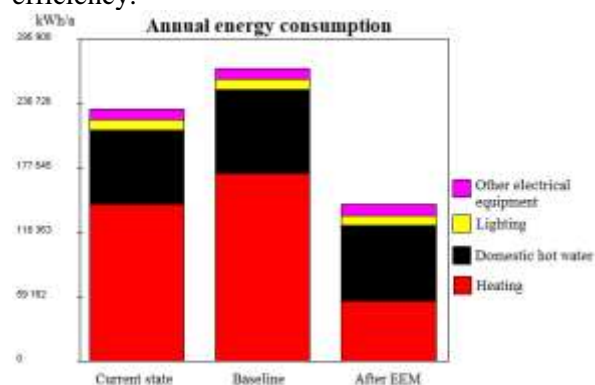
**Figure 7.** Outputs from the energy modeling of building 1.

A survey of the energy consumption in the buildings was carried out. The results of the survey are presented in Figures 7–10. The normalization of the energy consumption was needed, in compliance with the normative requirements for maintaining the necessary temperature comfort. For all four buildings, the normalized energy consumption is increased, indicating that at the time of the survey the buildings were under-heated.
