## Estimation of erosion-deposition trends across the Quang Nam coast in the background of the climate variability

Nguyen Tien Thanh✉

*Vietnam National University of Science, Ho Chi Minh City, Vietnam*

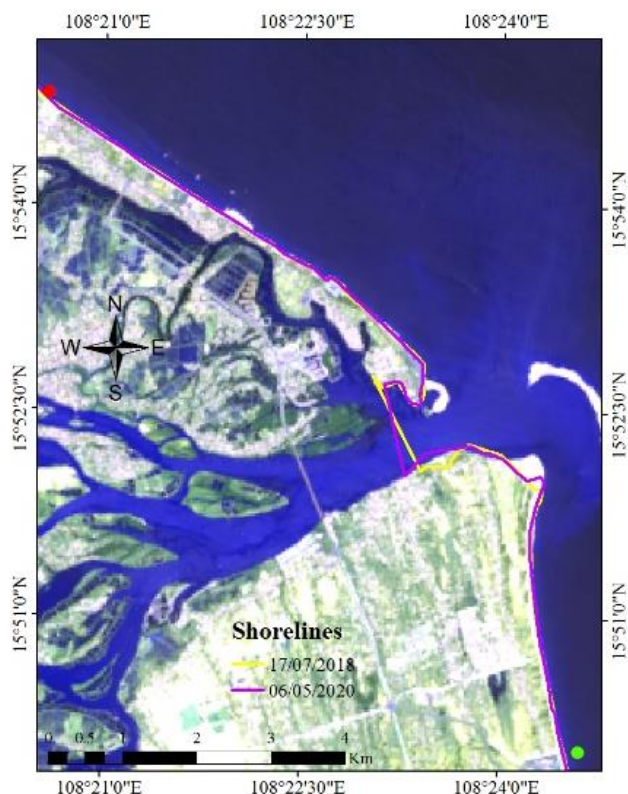
**Fig. 5.** Change of the area 1 shorelines, 2018–2020  
**Рис. 5.** Изменение береговой линии района 1 в 2018–2020 гг.

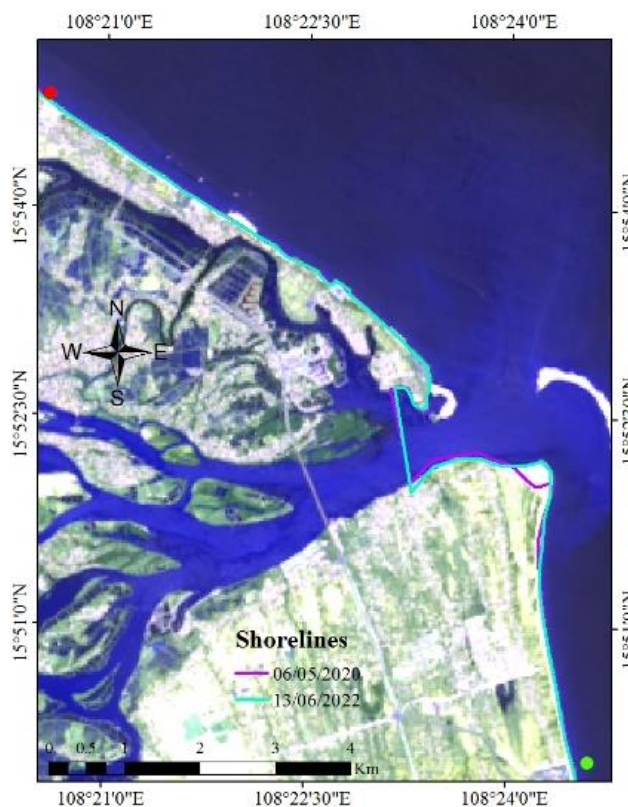
**Fig. 6.** Change of the area 1 shorelines, 2020–2022  
**Рис. 6.** Изменение береговой линии района 1 в 2020–2022 гг.
