Geotechnical properties of gullying in Tomsk Oblast

Abstract. The article deals with causes, conditions and factors of gullying in Tomsk Oblast, the case of site Grodnenskaya. A nuclear-power station was planned to be constructed in Closed Administrative Territorial Unit Seversk, which led to geotechnical investigation of the area to study the geological processes developing there. The investigation included reconnaissance traverse of the area, geological and geomorphic descriptions, and sampling. The area and percentage of the territory affected by the geological processes were estimated. As a result, it was proved that the geological processes of the area are conditioned by surface water activity leading to gullying and river erosion, and by both ground water and surface water activity resulting in bog formation. It appears that gullying is caused not only by natural factors but also by technogenic ones.

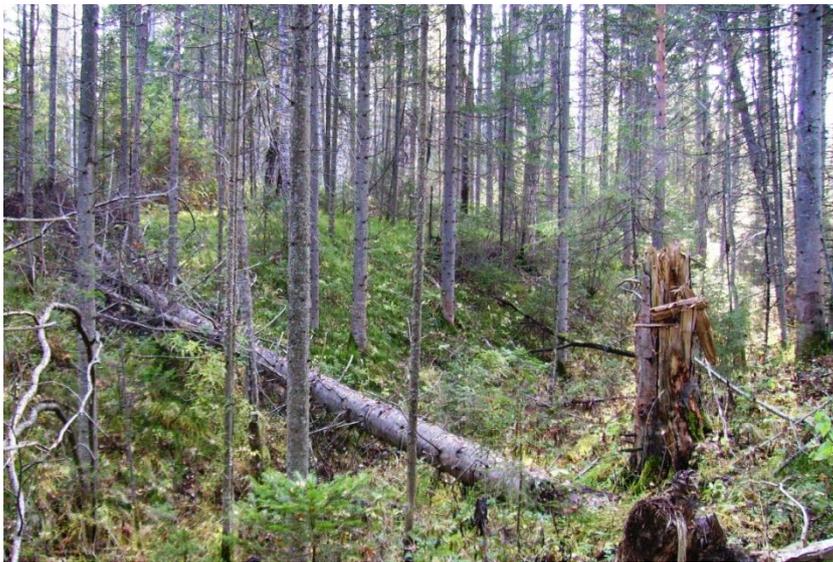
Figure 1. The gully on the studied site.

Gullying is the most developed geological process on Grodnenskaya site, which occupies almost 40% of the site [2] making the areas unsuitable for construction (fig.1).

The gully network can be classified as highly eroded [3]. A developed gully network with both dry and wet gullies spreads from the top of the site down toward the river valleys. Most of the gullies are grass-covered and forested; however, there are rare cracks and failures of the sides, which means that the erosion still continues.

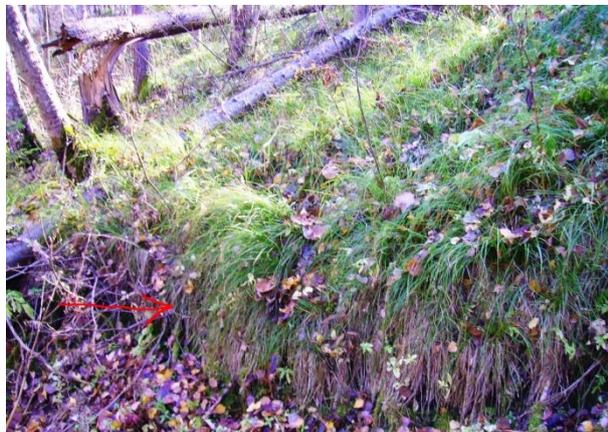
Figure 2. Slumping.

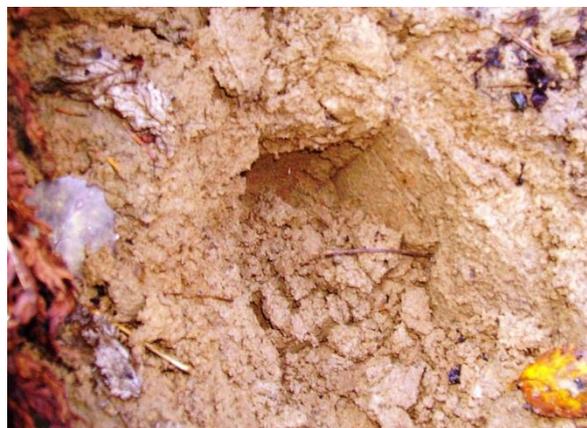
Figure 3. Sand clay in the gully side.

The gullies of the studied area are of different size: from 2 to 43 m wide, with 0.5-7.0 m deep. They are at different stages of development: from water galls and developing gullies to grass-covered and forested ravines. The length of the gully network is 1.5 km and more. The side slopes are usually covered with grass and subdued. The longitudinal section has the form of a smooth curve. The cross-section is of U-type. The slopes of gullies and ravines are covered with birch, aspen, abies, and small spruce (up to 40 cm high). There are a lot of windthrown trees. The sides are covered with thick grass: sedge, horsetail, fern, and etc. There occur small hills of sedge 7 cm high and of a diameter up to 25 cm, they are covered with moss. The side slopes are prone to slumping, cracks and paps (fig. 2). As a rule, a temporal flow cuts the gully bottom. The observed fresh cut, 40-105 cm wide and 15-30 cm deep, continues to develop the gully. Sand and sand clay are exposed in the cut (fig. 3).
