Article

# Hydride Rim Formation in E110 Zirconium Alloy during Gas-Phase Hydrogenation

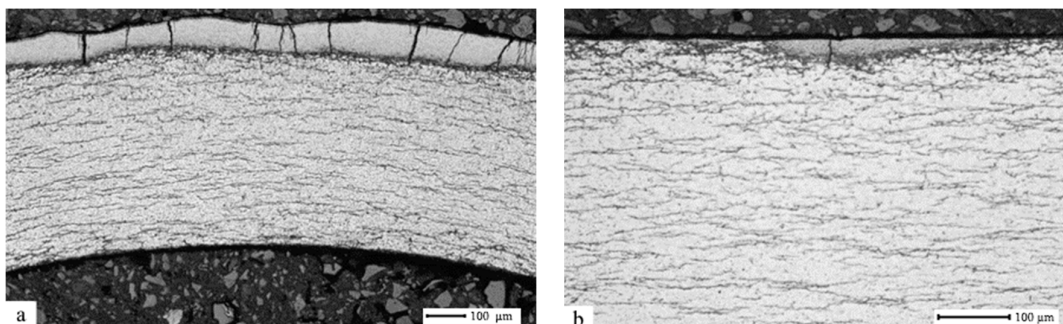
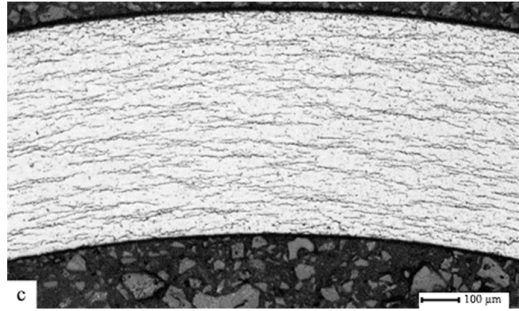
It has been established that the hydrogenation temperature effects hydride rim formation. Rim formation takes place at the temperature 320  $^{\circ}\text{C}$ , while, at the temperature 380  $^{\circ}\text{C}$ , the hydride rim is practically not observed, and at the temperature 420  $^{\circ}\text{C}$ , the hydride rim is not present. This is explained by the following: hydride rim formation takes place in the cases where the hydrogen solubility in the thin layer of zirconium alloy during hydrogenation is exceeded and the hydrogen absorption rate is higher than the hydrogen diffusion rate in relation to the observed thin layer. After hydrides have been formed in the thin layer, hydrogen diffusion penetrates through this layer further to the alloy volume, where hydrides are also being formed.

**Figure 1.** E110 zirconium alloy transverse metallographic section after hydrogenation at the temperatures 350 °C (a), 380 °C (b), and 420 °C (c), and the pressure 2 atm. up to hydrogen concentration 0.1 wt.%.

Below, Figure 1 presents the results of the metallographic examination using the optical microscope performed for the hydrogenated samples of the E110 alloy cladding tubes at the temperatures 350  $^{\circ}\text{C}$ , 380  $^{\circ}\text{C}$ , and 420  $^{\circ}\text{C}$ , with the pressure in the chamber 2 atm. up to a concentration of 0.1 wt.%.

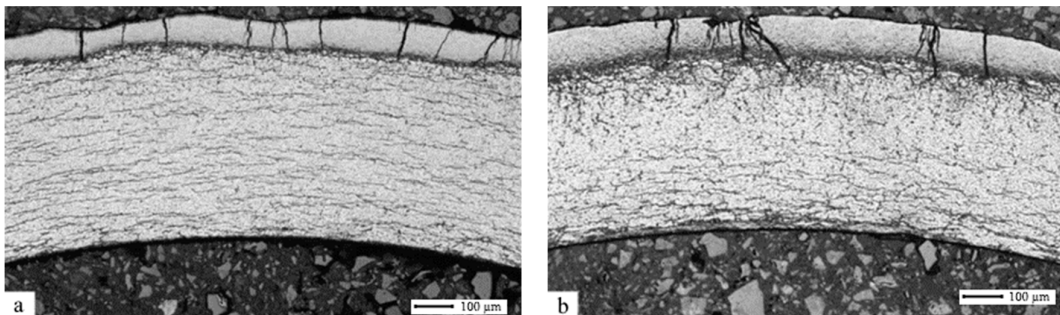
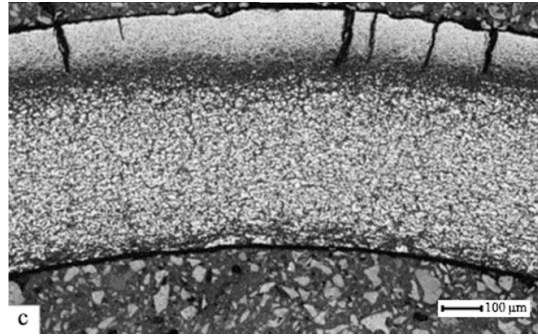
It has been established that hydride rim thickness depends on hydrogen concentration. An increase in concentration from 0.1 wt.% to 0.4 wt.% leads to an increase in the hydride rim thickness from 90 μm to 180 μm. Table 2 represents the results of the X-ray diffraction analysis of the samples of the E110 zirconium alloy cladding tubes after hydrogenation to different concentrations.

**Figure 2.** E110 zirconium alloy transverse metallographic section after hydrogenation at the temperature 350 °C and the pressure 2 atm. up to concentrations 0.1 (a) – 0.25 (b) – 0.4 (c) wt.%.

Below, Figure 2 presents the results of the metallographic examination using the optical microscope performed for the hydrogenated samples of the E110 alloy cladding tubes at the temperature 350 °C, the pressure in the chamber 2 atm., and up to concentrations 0.1–0.25–0.4 wt.%.

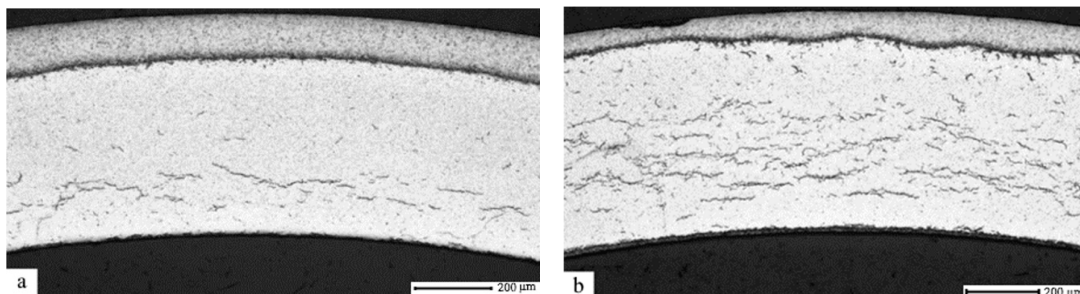
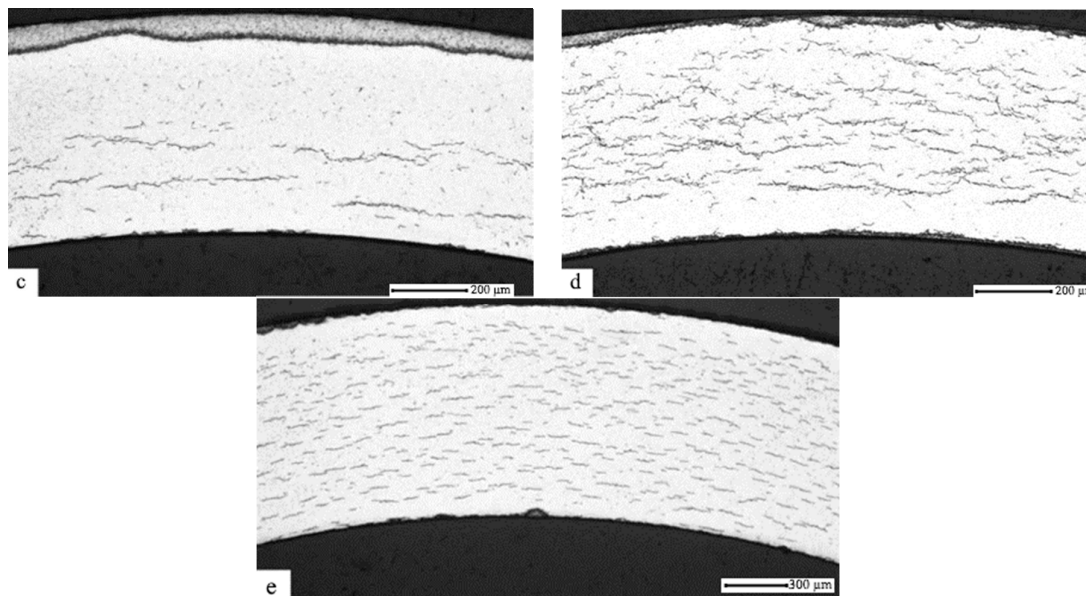
**Figure 3.** E110 zirconium alloy transverse metallographic section subjected to ion-beam cleaning and nickel coating after hydrogenation at the temperatures 350 °C (a), 400 °C (b), 450 °C (c), 500 °C (d), and 550 °C (e), and the pressure 2 atm. up to hydrogen concentration 0.1 wt.%.

It has been established that hydride rim formation in the E110 zirconium alloy subjected to ion-beam cleaning and nickel coating takes place at the temperatures 350 °C (a), 400 °C (b), and 450 °C (c). At the temperature 500 °C, the hydride rim is practically not observed, and at the temperature 550 °C, the gradient is not present.

Below, Figure 3 presents the results of the metallographic examination using the optical microscope performed for the hydrogenated samples of the E110 alloy cladding tubes subjected to ion-beam cleaning and nickel coating (the method of ion-beam cleaning and nickel coating is described in [23]) at the temperatures 350 °C, 380 °C, 420 °C, 500 °C, and 550 °C. The pressure in the chamber is 2 atm. and up to the concentration of 0.1 wt.%.

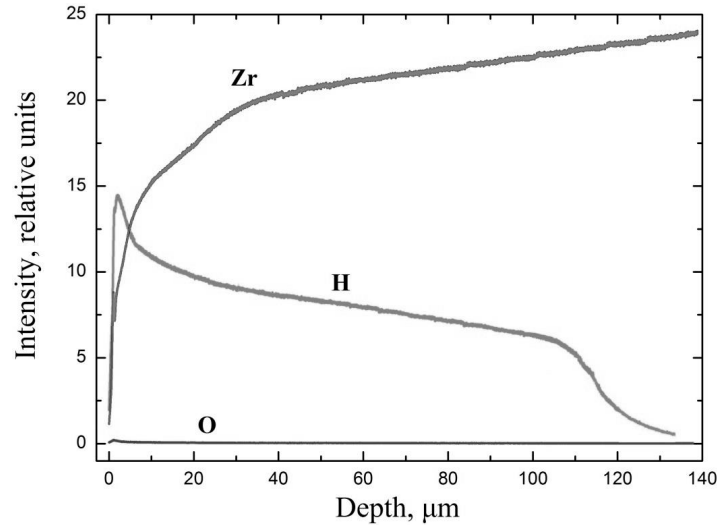
As the studies have revealed, there is a layer up to  $\sim 110 \mu\text{m}$  with high hydrogen concentration in the sample. At that, with the depth growth, the zirconium signal strength increases, which evidences the decrease of hydrogen concentration and the presence of the gradient of hydrogen distribution right in the hydride layer. This can be explained by the following: hydride formation takes place immediately after hydrogen penetration in a thin layer of zirconium. Further penetration of hydrogen leads to an increase in the thickness of the hydride layer directly in the process of hydrogenation. This situation is observed at a high hydrogen penetration rate and a low diffusion rate. In our experiment, this was achieved by cleaning the surface, high pressure, and low

**Figure 4.** Distribution of elements through the thickness of E110 zirconium alloy with the formed hydride rim of the thickness 110  $\mu\text{m}$  at the temperature 350  $^{\circ}\text{C}$ .

Below, Figure 4 presents the results of the studies of element distribution throughout the thickness of the E110 zirconium alloy with the formed hydride rim of the thickness 110  $\mu\text{m}$ . The element signal strength is presented in the relative unit values, since, to be able to determine hydrogen concentration using this method, it is necessary to prepare the reference samples of hydrogen and oxygen in zirconium alloys. However, based on the correlation of the signals of different elements, it is possible to judge the correlation of these elements' quantities in the samples.

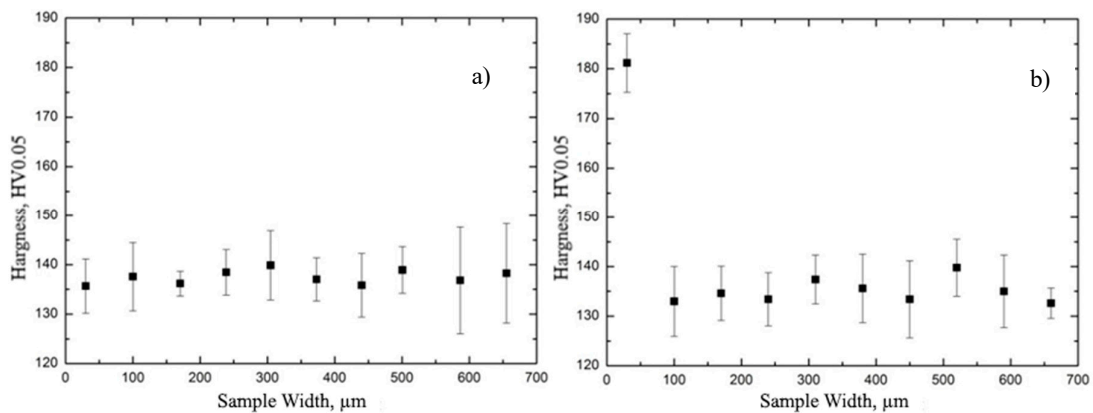
**Figure 5.** The measurement results of E110 zirconium alloy microhardness before (a) and after (b) hydrogenation, with the hydride rim formed with the thickness of 110  $\mu\text{m}$ .

The volume of the zirconium alloy is characterized by the uniform distribution of hardness in the thickness. After hydrogenation at the temperature lower than the threshold temperature, the hardness significantly increases up to the depth of 100  $\mu\text{m}$ , which can be explained by hydride rim formation. The results of the studies of the sample's nanohardness distribution in the transverse metallographic section are presented in Figure 6.

This fact has been confirmed by the studies of the sample's nanohardness distribution in the transverse metallographic section. The measurement results for the sample's microhardness before and after hydrogenation are presented in Figure 5. The hydride layer is characterized by high hardness in comparison to the material volume.

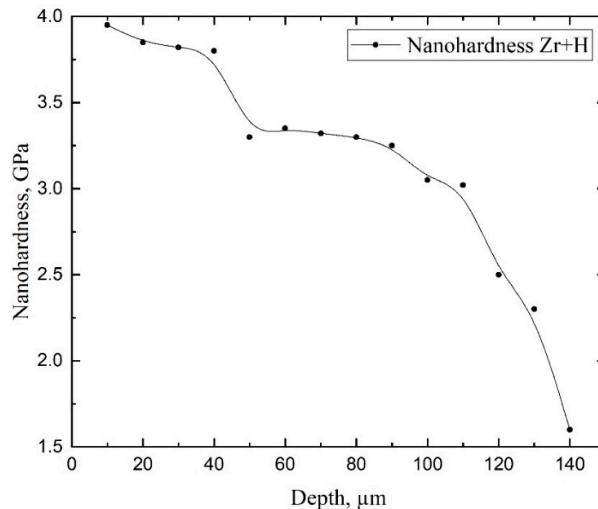
**Figure 6.** The measurement results of nanohardness of E110 zirconium alloy with hydride rim 110  $\mu\text{m}$ .

As the studies have revealed, hardness in the hydride rim decreases from the outer layer into the material volume, which evidences the presence of the hydrogen concentration gradient in the hydride rim, which, in turn, confirms the suggested mechanism of hydride rim formation. In the hydride rim, in regions close to the surface, hydrogen concentration is very high, and the formation of epsilon hydrides takes place. By approaching towards the bulk, hydrogen concentration decreases, and at some depths, it is not enough for epsilon hydride formation. Hence, the delta hydrides form. The observed variation in hardness is due to this phase change: i.e., close to the surface, we are measuring the hardness of epsilon hydrides, but close to the bulk, we are measuring the hardness of delta hydrides.
